DISTRICT OF WELLS PRELIMINARY INFLOW & INFILTRATION REVIEW

Prepared for: District of Wells

October 2022 954-009-01

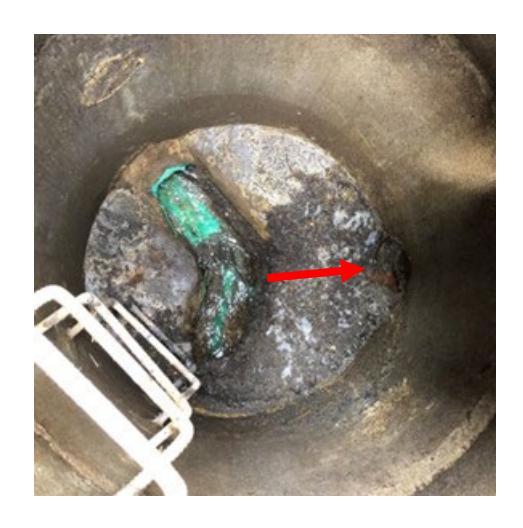
Image #2: 4-Inch PVC Pipe in Manhole #60

Manhole inspections showed that most manholes in the community are in good condition. Some of the manholes did show minor signs of staining and some minor groundwater seepage was present at the time of the inspection. Three (3) manholes were in fair condition, showing small amounts of infiltration. Three (3) manholes were in poor condition, showing major signs of infiltration. One manhole, manhole #60, had significant inflow issues. This manhole had a four-inch PVC pipe installed into the side of the manhole wall and out into the Willow River. It is unknown when or by whom the drainage pipe was installed. During normal operating conditions, the pipe would allow surface water to inflow into the collection system. However, during power outages or maintenance issues with the lift station, the collection system would back up and flow out into the Willow River. Upon finding the pipe, Radloff and the District of Wells immediately capped this pipe during the site visit, however a permanent cap should be installed. For reference to manhole conditions and manhole #60, refer to photos in *Appendix A*. For locations of the manholes refer to the drawings in *Appendix B*.

The infiltration repair recommended is the sealing of leaking manhole barrel joints (e.g., manhole #60), and a permanent cap being installed on the capped drainage pipe on manhole #60. As the groundwater rises, the increased water pressure causes water to leak in through cracks or holes in the manhole riser joints. Traditional grouting alone has been known to fail over time due to inward pressure from the ground water. It is recommended that grouting be completed in combination with a hydrophobic grout injection. The hydrophobic grout is a rapid reacting material that expands when it contacts water and forms a seal around the manhole, cutting off the water and thus the infiltration. For the grout to work properly, it must be applied <u>during peak infiltration events.</u> With no high groundwater the product will not expand properly. Once the water source has been cut off, the manhole barrel joint should be re-grouted.

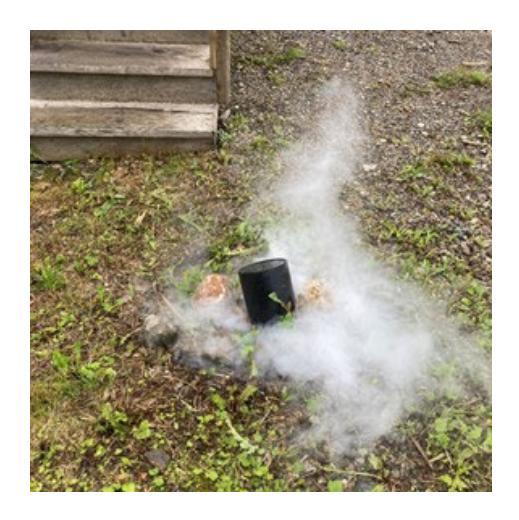
Image #4: Smoke from Above Grade Cleanout

Smoke testing revealed a total of twelve (12) service cleanouts that were broken and can be a significant source for inflow. This does not include the cleanouts in the RV park. Three (3) cleanouts were not capped properly, two (2) cleanouts were visibly broken, four (4) cleanouts were leaking below grade, and the remaining three (3) cleanouts were visible but leaking below grade. The leaking cleanouts protruding above ground are believed to present only minor inflow volumes. The broken and below grade cleanouts could potentially be a source of significant inflow. In the RV park, there were multiple service cleanouts that were leaking. It is recommended that all these cleanouts be repaired/capped.

Twelve (12) clean out locations were found during smoke testing that should be repaired to help reduce inflow and infiltration into the wastewater collection system. For reference to the inflow repair locations, refer to *Appendix B*. These should be lowered below the ground surface and capped. A covering metal sleeve/cap is to be installed below ground level and the cleanout buried with clay soil. The metal sleeve will permit the cleanout to be located in the event that access is needed for operations or maintenance purposes. For reference to the recommended repairs, refer to the drawing in *Appendix C*.

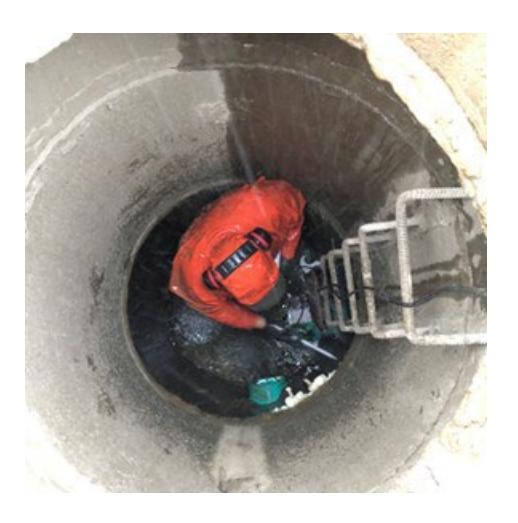
Image #5: Manhole Repair with Hydrophobic Grout

As significant infiltration was witnessed at manhole #65A during the previous manhole inspections completed earlier in the year, Radloff brought out confined space equipment and hydrophobic grout to enter the manhole if a leak was discovered during the inspection. This would allow inspectors to repair any major issues in the event one was located during the inspection.

Sewer manhole #65A at the intersection between Highway 26 (Barkerville Highway) and Ski Hill Road showed a large amount of infiltration leaking into the sanitary system. Hydrophobic grout was used to patch the major leaks, but there were still several more minor leaks around the barrel joint and inflow pipe. The leaks in this manhole require further re-grouting.

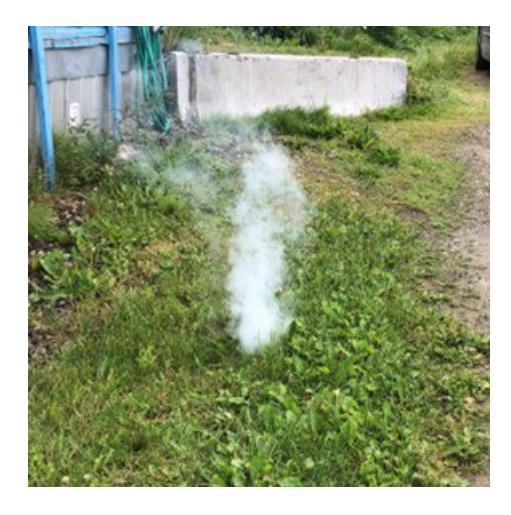
Image #6: Smoke from Below Grade Cleanout

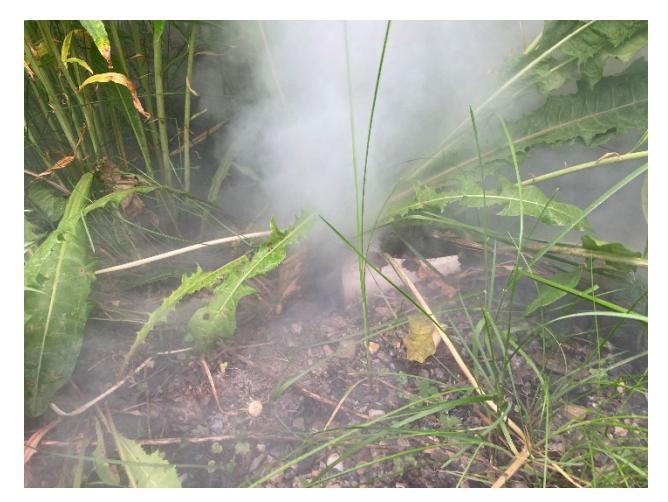
Figure 1: Cracked cleanout at ground level near 3879 Solibake St.

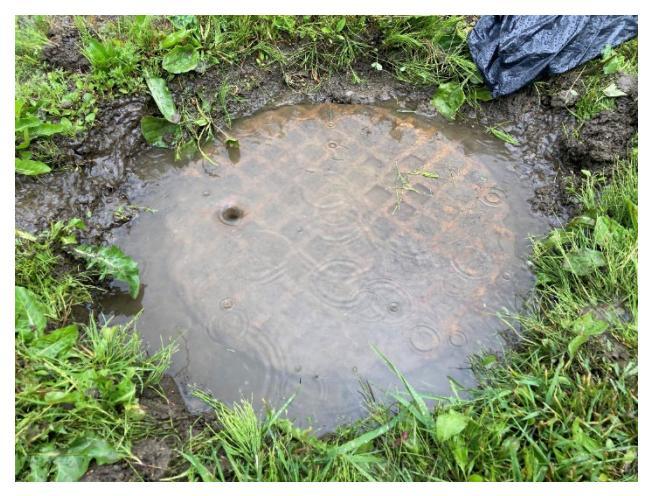
Figure 2: Inflow location - Manhole near Barkerville Highway bridge crossing Willow River

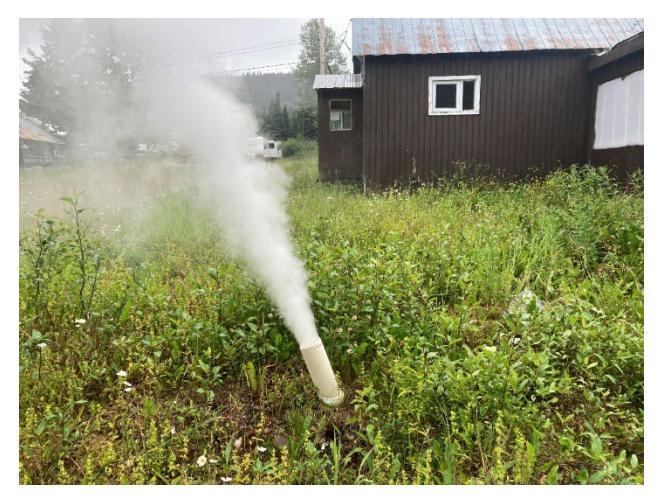
Figure 3: Cleanout without cap at 3968 Mooney Ln.

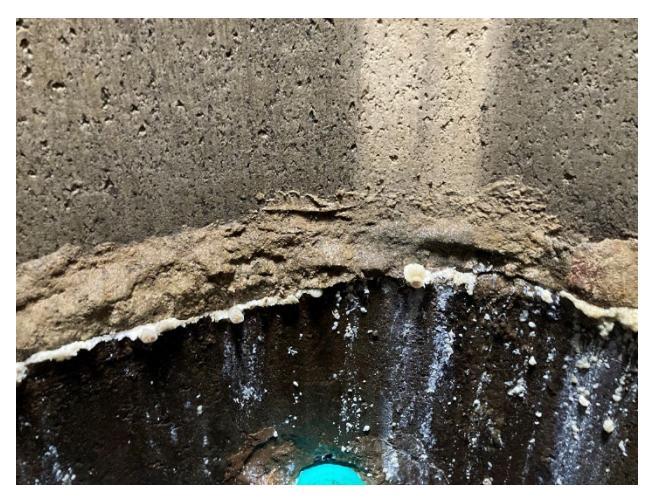
Figure 4: Hydrophobic grout injection in barrel joint of manhole #65A

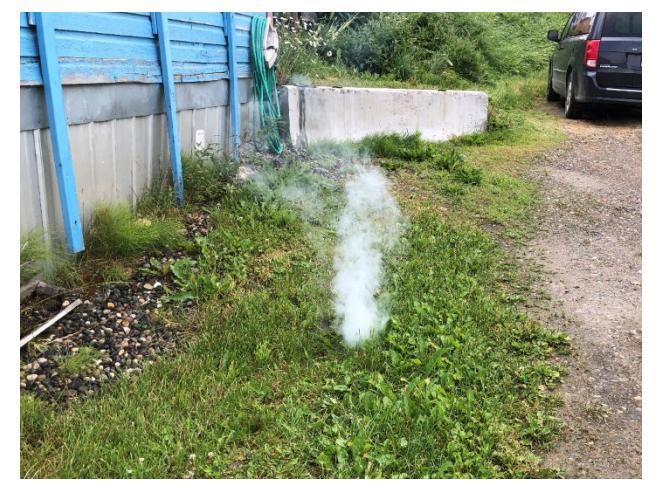
Figure 8: Smoke indicating broken cleanout below grade

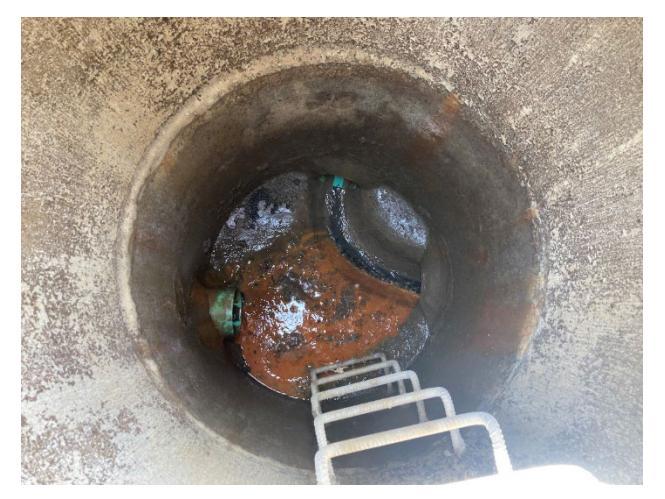
Figure 7: Rust indicating infiltration

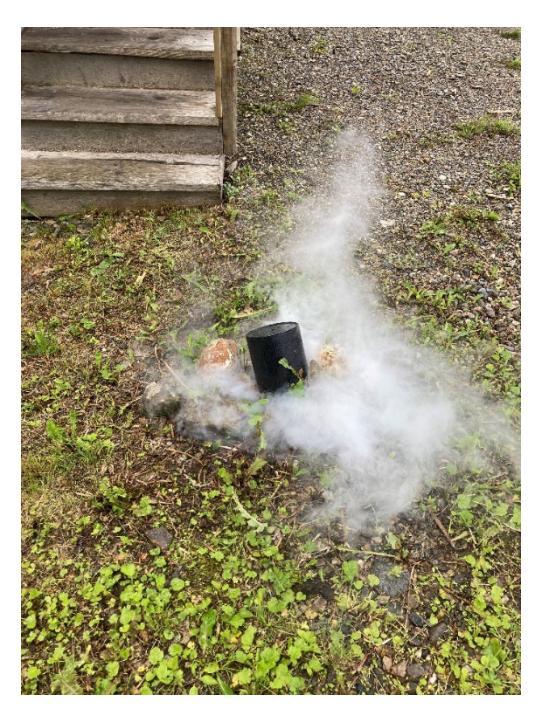
Figure 5: Smoke from ground around cleanout indicating breakage

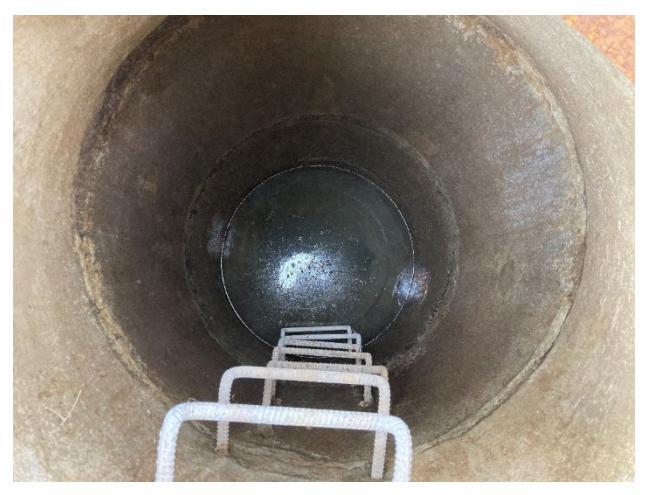
Figure 10: Backed up manhole

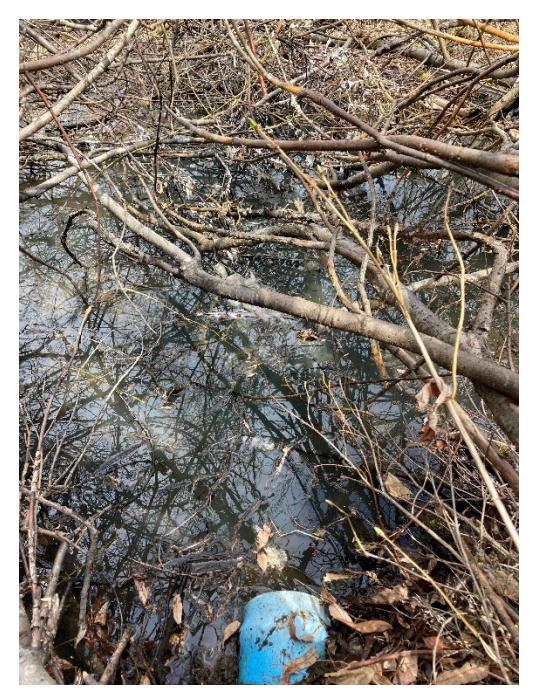
Figure 11: 4-inch pipe draining sewage into the Willow River

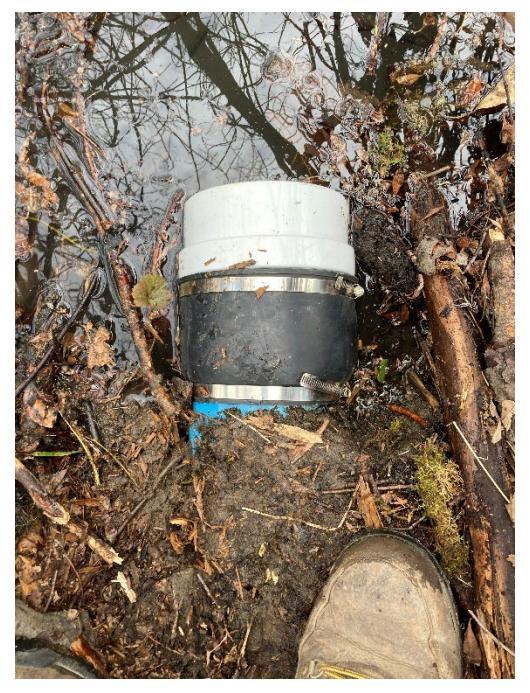
Figure 12: Capped 4-inch pipe (temporary fix)
