District of Wells Regional Flood Hazard Assessment

Project 2546-006

Document 2546006-001-RP-RevA

Regional Flood Hazard Assessment – DRAFT

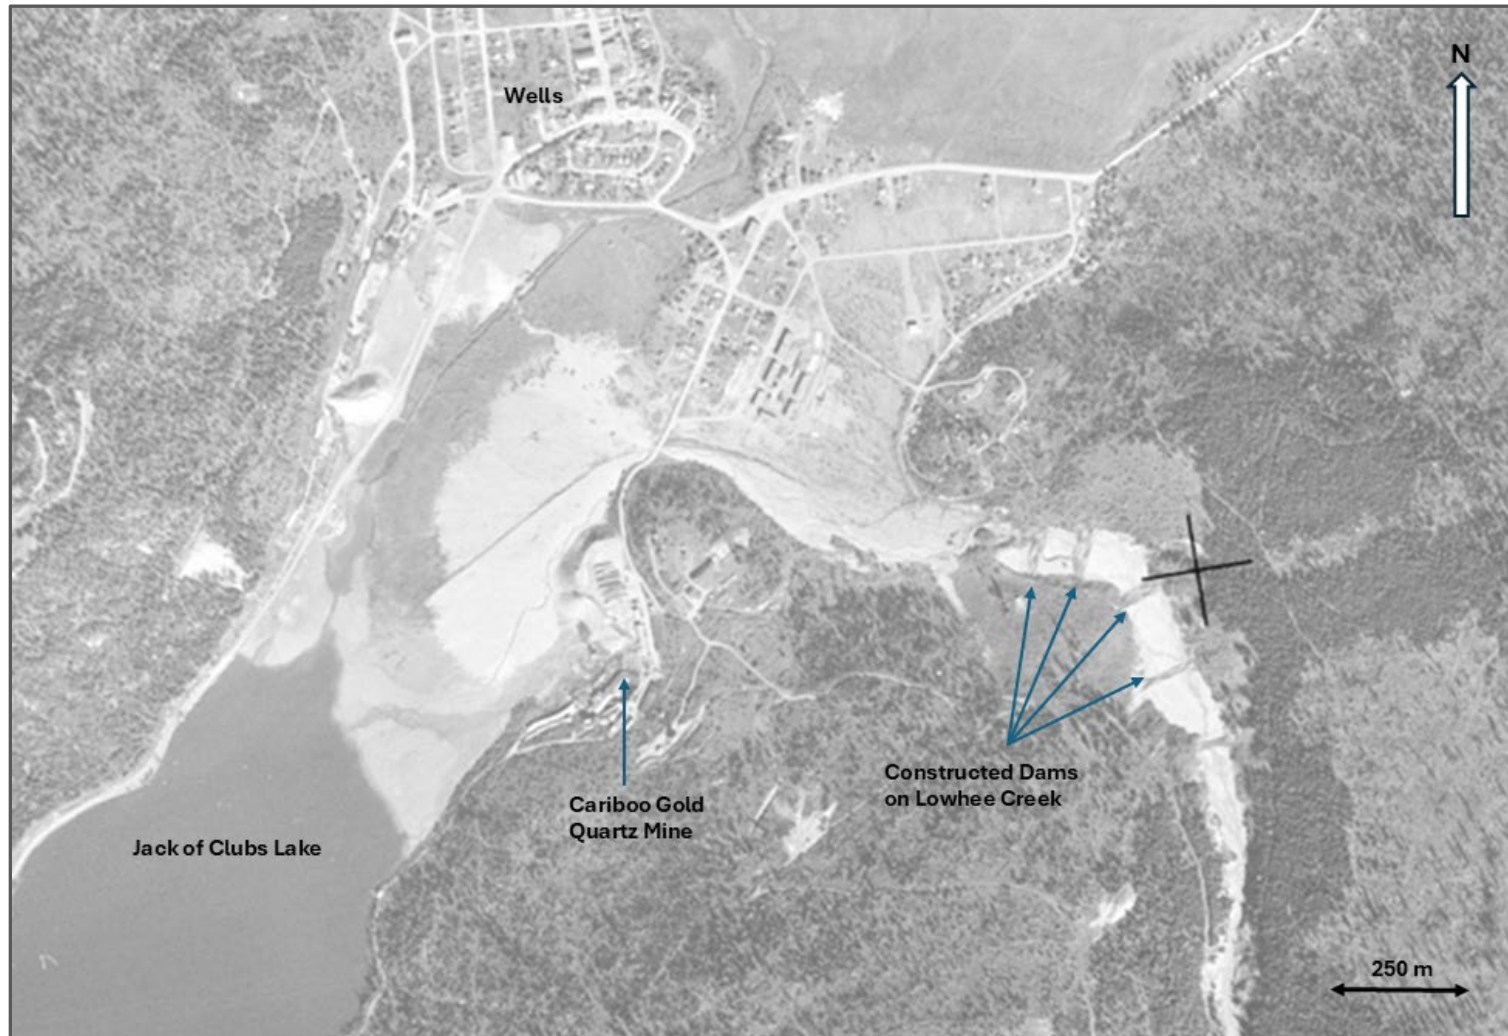
Figure 2-3 1952 airphoto showing constructed dams within the Lowhee Creek lower watershed. Photo source: NAPL⁴, September 1, 1952.

Archival photos of the placer operations from Lowhee Creek show the extraordinarily large volumes of sediment mined (Figure 2-2) as do historical air photos. Historical air photos also show constructed dams within the lower 500 m of the stream (Figure 2-3). The purpose of these dams is unknown, though based on anecdotal evidence from community members, the dams were likely constructed to retain sediment from the upstream hydraulic mining operations. Remnants of these dams are visible in modern imagery and on the ground.

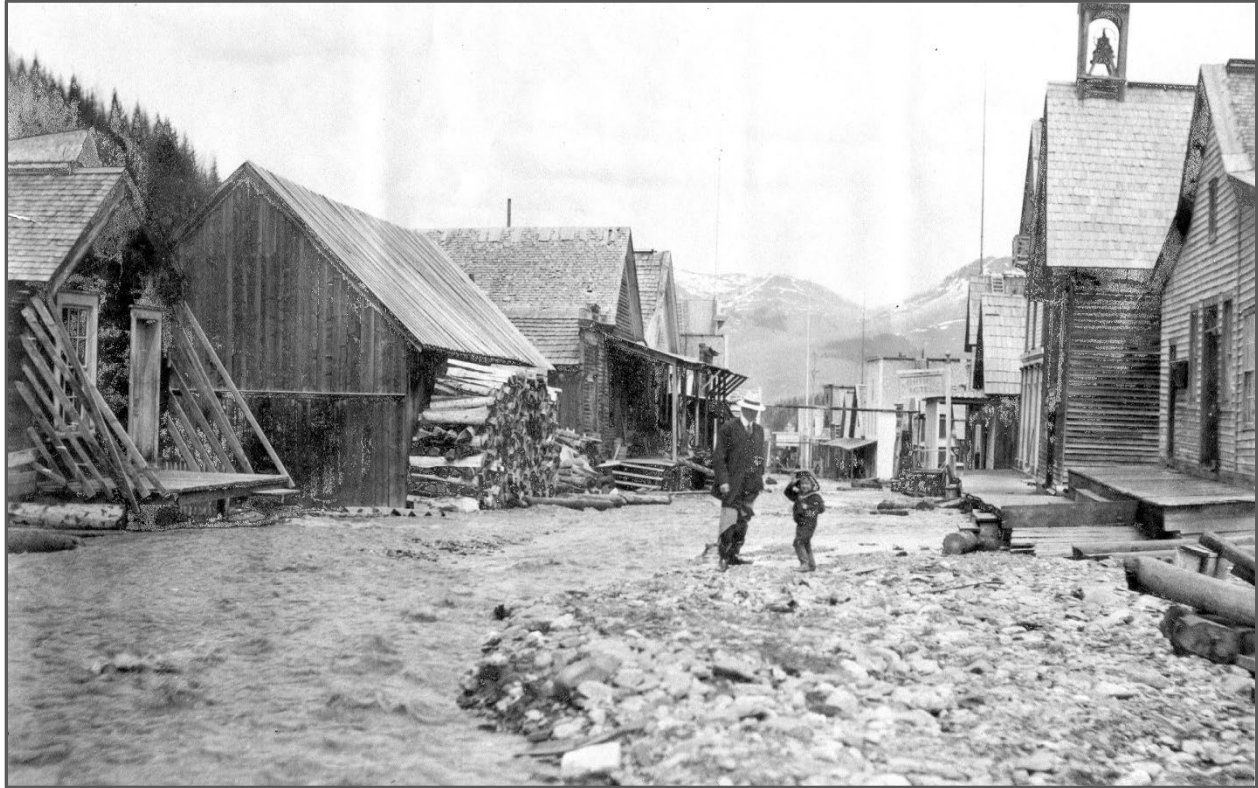
aggradation of the creek bed was likely extreme due to the upstream disturbance caused by placer mining. Indeed, flood events in Barkerville prior to the 1930s arrived with such frequency that, except for the most extreme, they appear not to have been reported on (Galbraith, 2011) (Figure 4-1).

Figure 4-1 Main Street of Barkerville during a flood on June 11, 1911. Barkerville photograph collection, P2767.

The most destructive flooding appears to have occurred on April 5, 1879. Records indicate that after the flood buildings had to be raised as much as 5 m (17 feet) because of the placer tailings that had washed into town.

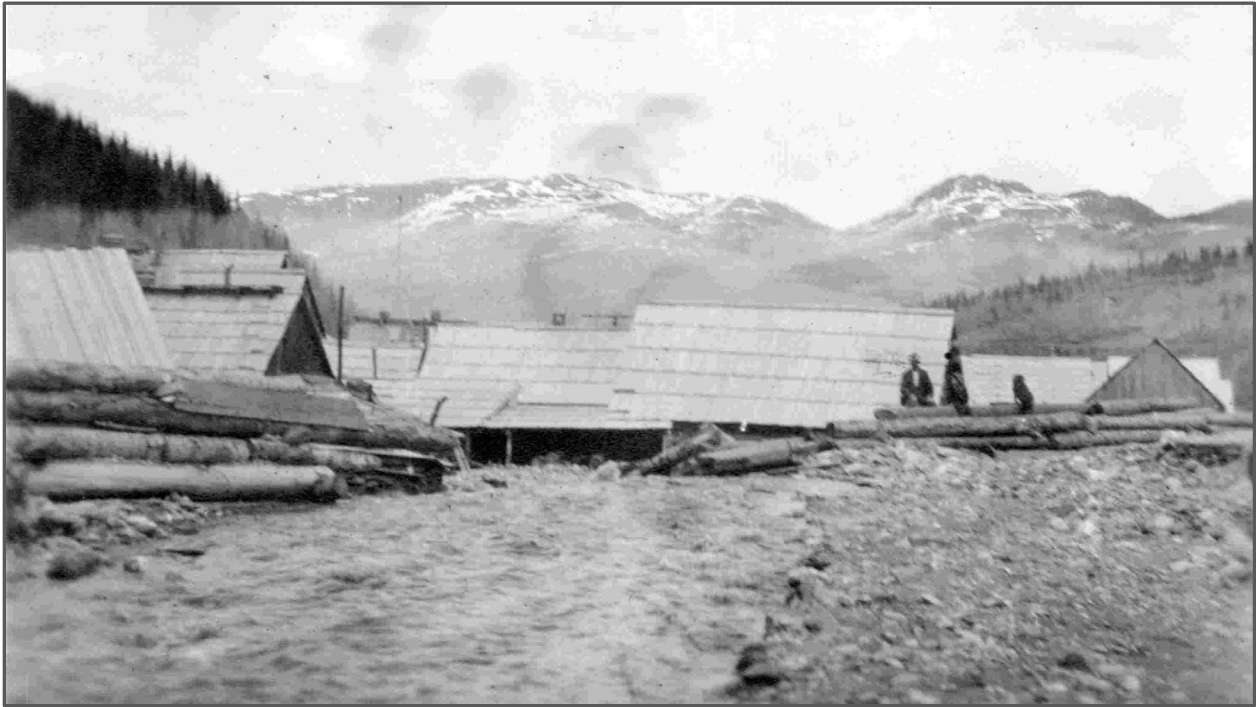
The primary method used to prevent flooding of the townsite was to build along the west side of the valley and to force the creek to the east side using a flood bulkhead¹⁴. The earliest photographs indicate that the bulkhead originally consisted of logs placed one above the other, horizontal to the ground, with logs placed intermittently at right angles along the wall to provide buttress support (Figure 4-2). Construction techniques evolved over time. A 1934 photograph shows horizontal boards, rather than logs, attached to widely spaced, upright supports.

Figure 4-2 Williams Creek flood breaking through the bulkhead. Barkerville photograph collection, P4333. Unknown date.

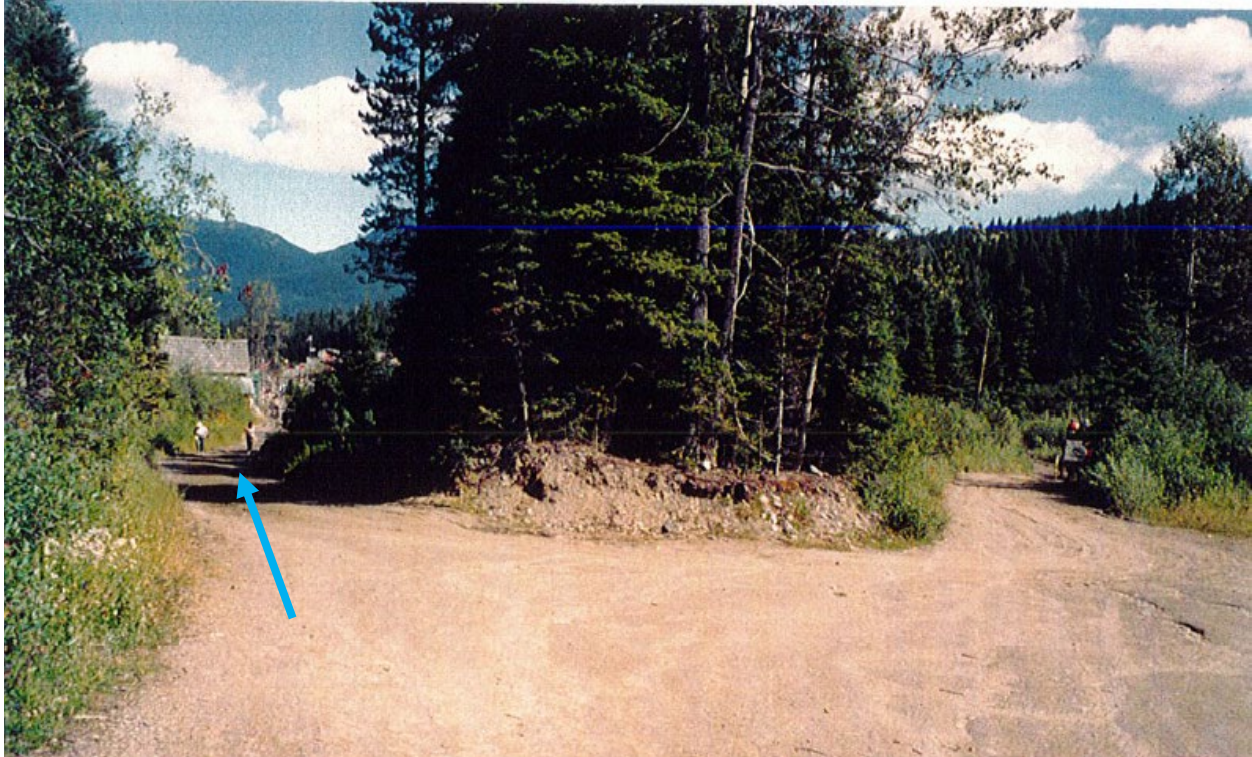
Figure 4-3 View looking north at the south end of the Main Street/service road loop. The blue arrow shows the flow direction that allowed Stouts Gulch overflows to reach the townsite in 1993. Photograph of August 27, 2001 (Galbraith, 2001). McElhanney (2010) recommended that the road be raised in this area for flood control. However, this work was never completed.

The only reported instance of Barkerville flooding between the 1930s and present is May 15, 1993, when the Stouts Gulch bridge became blocked by debris during a period of rapid snowmelt (Quackenbush, November 27, 1997). The creek flows then avulsed northeast toward the townsite (Figure 4-3), resulting in considerable damage to community infrastructure (Figure 4-4). Significant work was completed to repair the damages and restore the townsite. Overflows also reportedly occurred on Williams Creek adjacent to the water wheel.

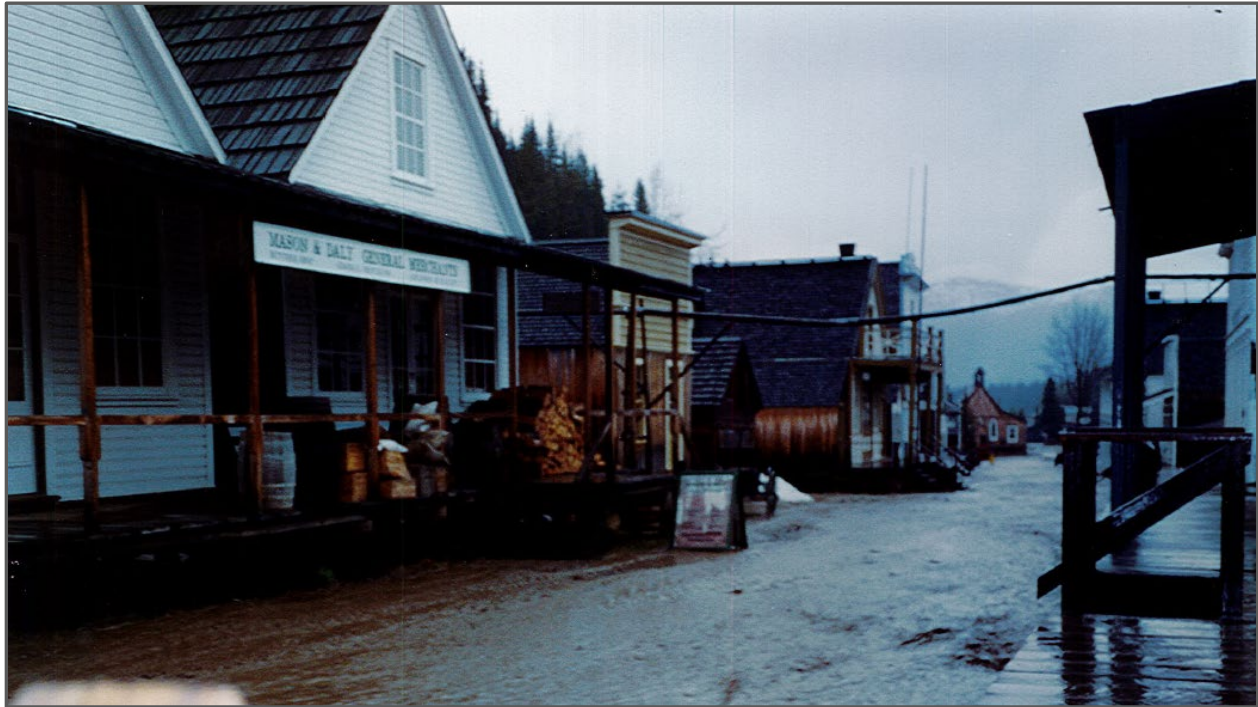
Figure 4-4 View looking north of flood along Main Street in Barkerville on May 15, 1993. Photograph of Pat Taylor provided to BGC by the Barkerville Heritage Trust.

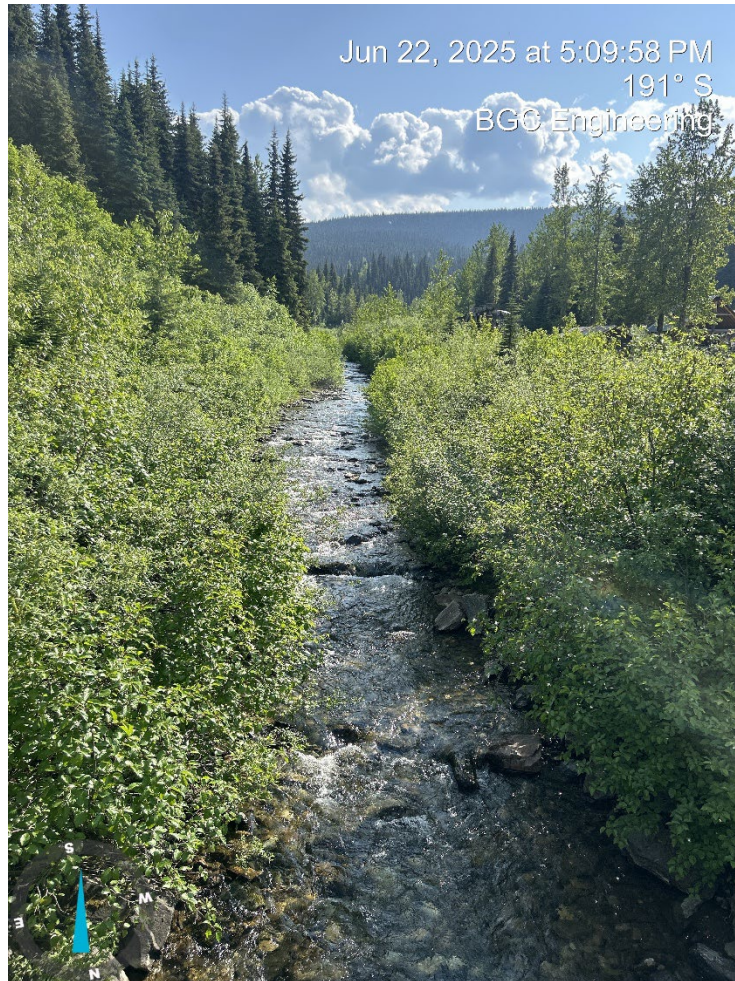
Riprap has been placed on the left bank of Williams Creek in a few select locations within the townsite, but its placement is irregular. During BGC's 2025 site visit, heavy vegetation along the left bank made it difficult to ascertain where riprap was and was not present (Figure 4-5). Photographs from Galbraith (2001), when the left bank was much less vegetated than it is today, do illustrate the selective nature of riprap placement.

Figure 4-5 Upstream view of Williams Creek from the footbridge. BGC photograph of June 22, 2025.

In 2001, Galbraith describes how the left bank near the water wheel had only 1.5 m of clearance to the creek bed relative to upstream and downstream sections. The bank height was raised to 2 m in this area and riprap was placed from approximately 50 m upstream of the water wheel to 10 m below the footbridge (Galbraith, 2002). Bunches of slide alder were also planted and a row of boulders removed from the creek.

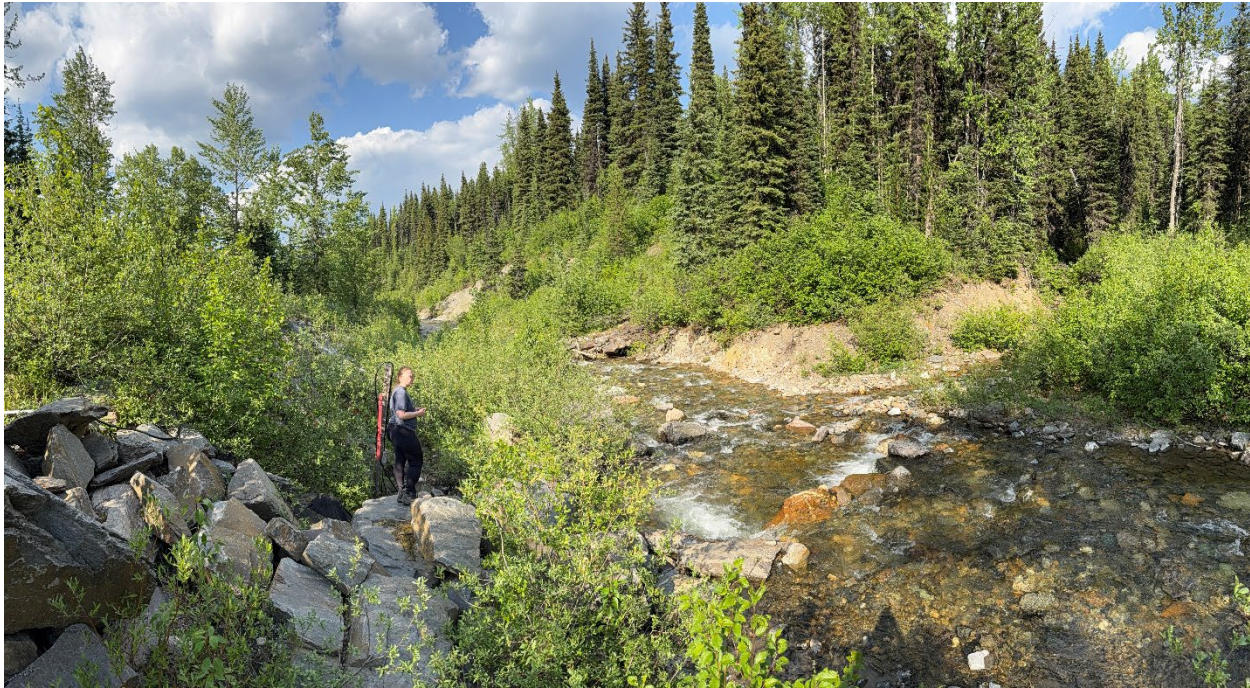
Figure 4-6 Downstream view of Williams Creek at confluence with Conklin Gulch. Note the riprap on the left bank. BGC photograph of June 22, 2025.

A 2010 ice jam flood resulted in the erosion of a portion of the Williams Creek left bank at Conklin Gulch, exposing the supply line pipe. The creek bank was restored and armoured as part of emergency works in 2010 (McElhanney, 2011) (Figure 4-6).

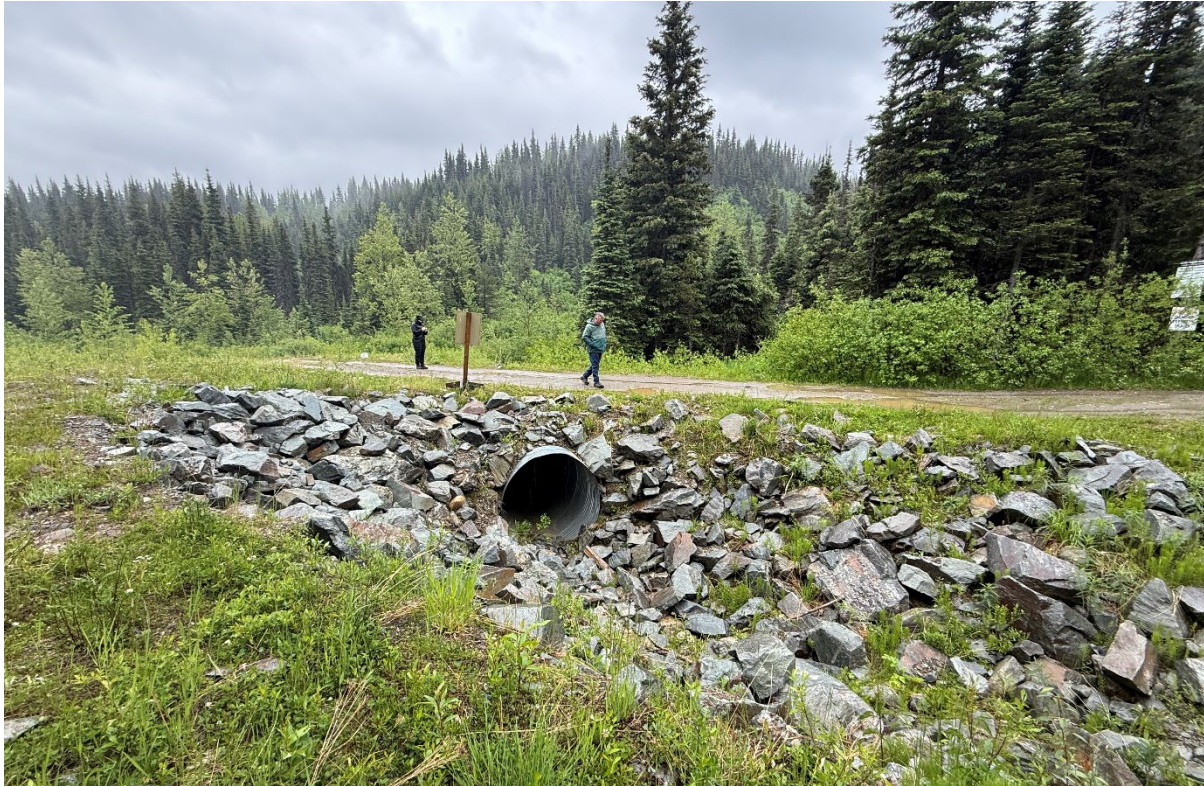
Figure 4-9 Downstream view of Stouts Gulch overflow culvert crossing of Richfield Road. BGC photograph of June 23, 2025.

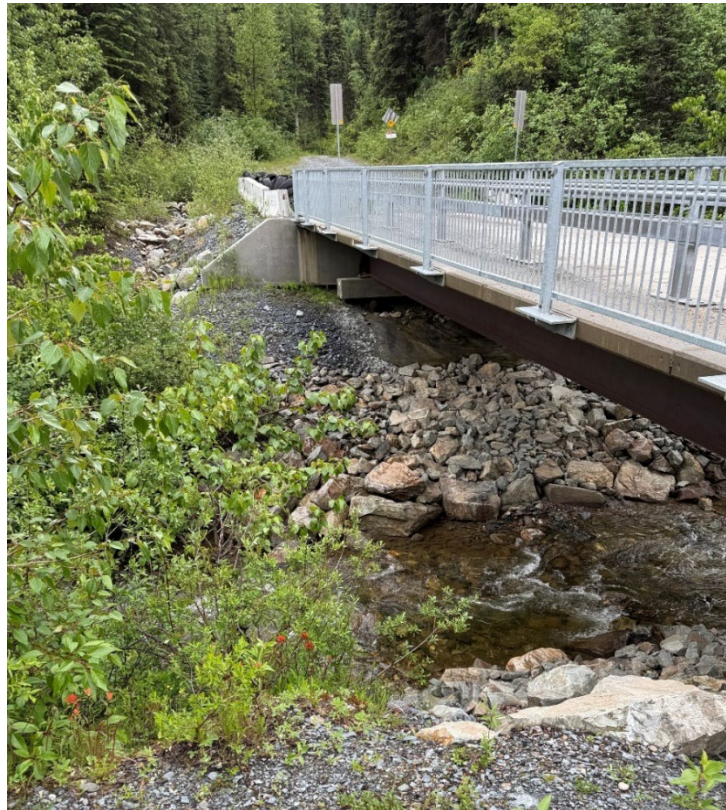
The downstream Prosperpine bridge was constructed in 2018 (Figure 4-11). Both abutments are protected with riprap. BGC measurements indicate that the riprap has the following approximate dimensions: $D_{10} = 170$ mm, $D_{50} = 270$ mm, and $D_{90} = 450$ mm. The bridge deck consists of 0.2 m thick concrete running surface supported by 1.2 m thick steel girders.

Figure 4-11 Upstream view of Prosperpine Bridge crossing of Williams Creek at entrance to historic Barkerville Town. BGC photograph of June 24, 2025.

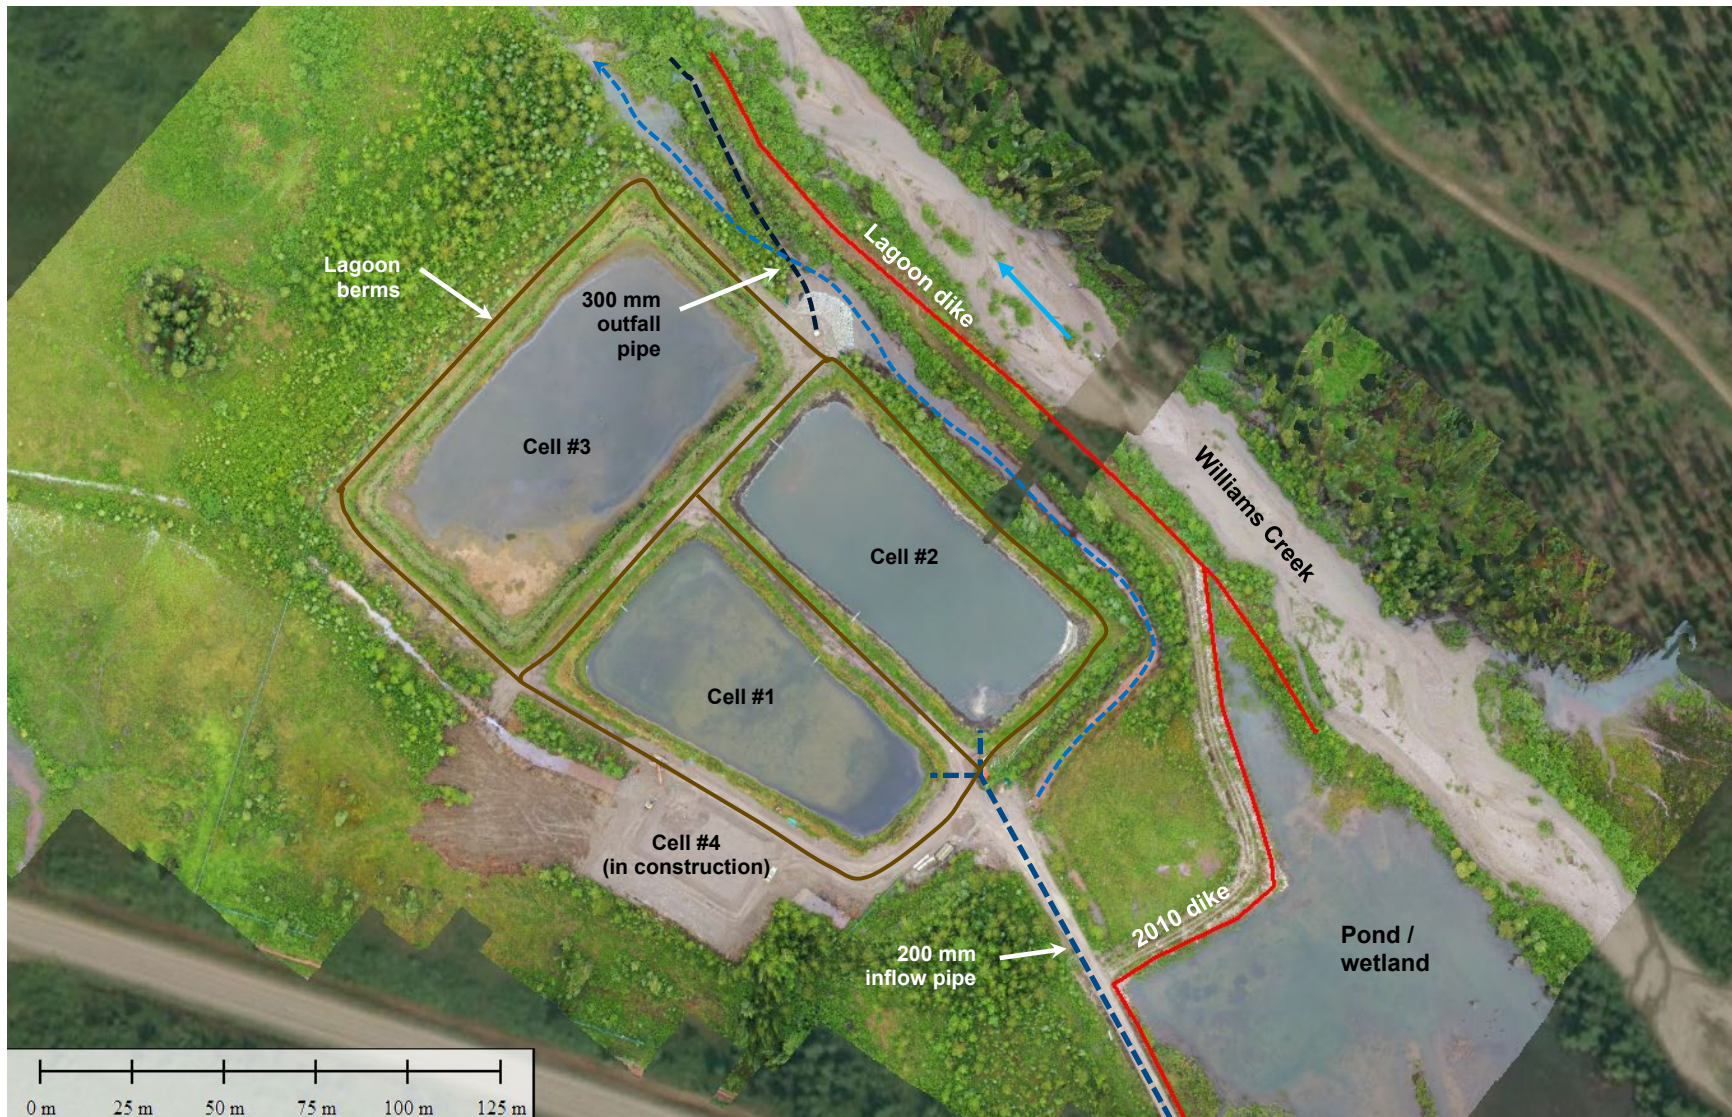
Figure 4-12 BGC June 23, 2025 drone photograph of Barkerville wastewater lagoons.

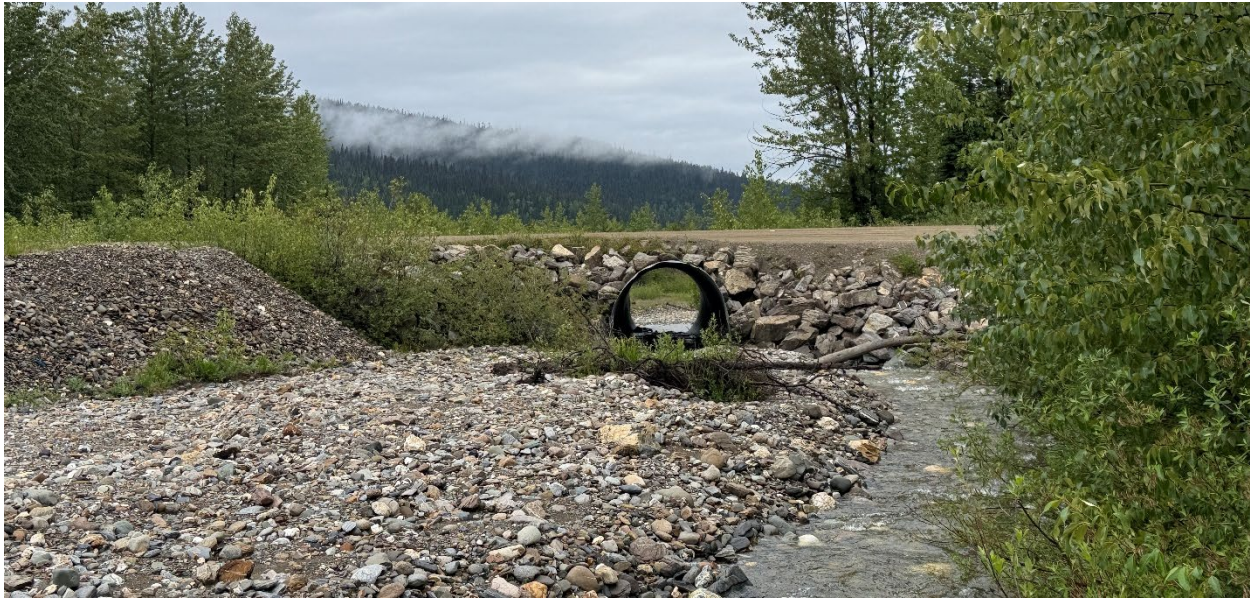
At Bowron Lake Road, Williams Creek flows through a 3 m diameter corrugated steel pipe (Figure 4-14). In 1991, Bowron Lake Road crossed Williams Creek approximately 85 m to the southeast. The current road alignment, which now includes an S-bend, was presumably adjusted to accommodate excavation of the Ballarat open pit in the 1990s. Maintenance and operation of Bowron Lake Road and the 3 m diameter culvert are the responsibility of the BC Ministry of Transportation and Transit (MoTT).

Figure 4-14 Downstream view of Williams Creek culvert crossing of Bowron Lake Road. BGC photograph of June 24, 2025.

The Ballarat open pit is now flooded, although water levels in the pit are typically much lower than in Williams Creek. When the 2021 lidar was acquired, water levels in the pit were approximately 4.5 m lower than in Williams Creek. At higher pond levels, there is a 600 mm diameter culvert at the north end of the pit that allows the pond to drain under Bowron Lake Road and into Williams Creek.

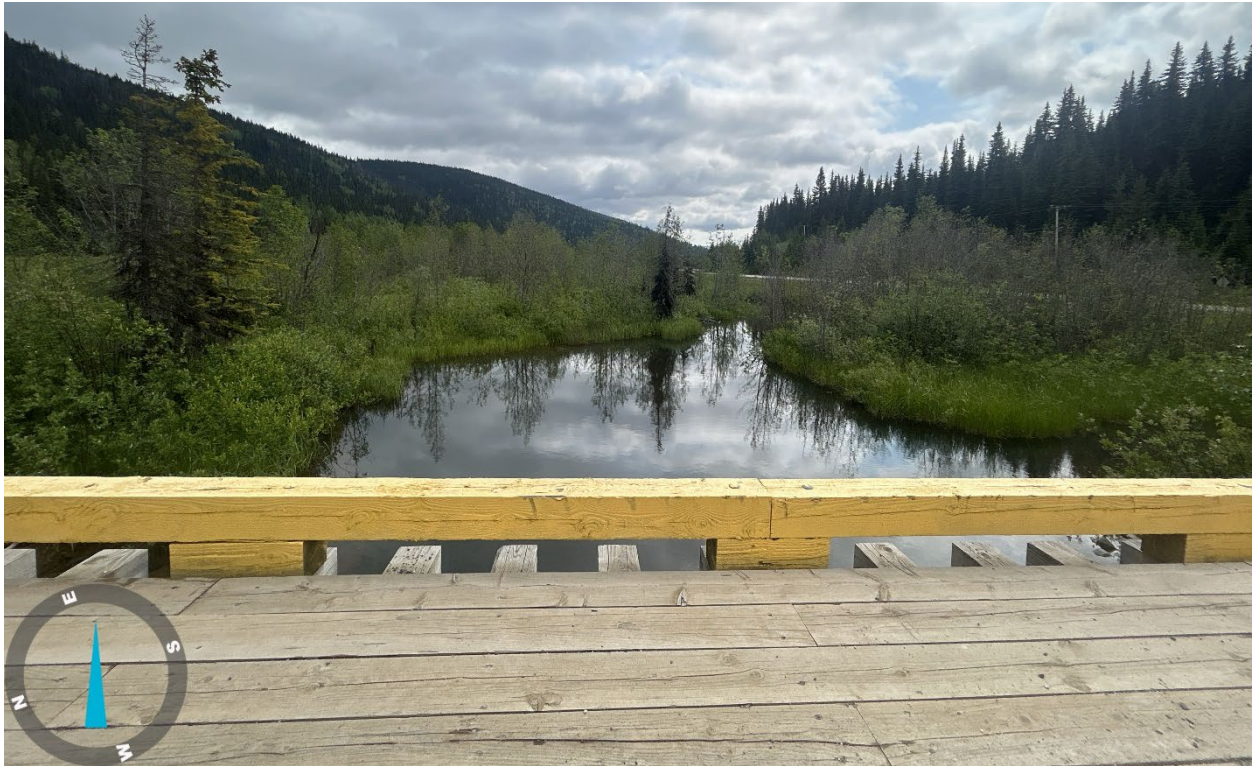
Figure 4-15 Upstream view of Williams Creek at One-Mile Road bridge crossing. BGC photograph of June 23, 2025.

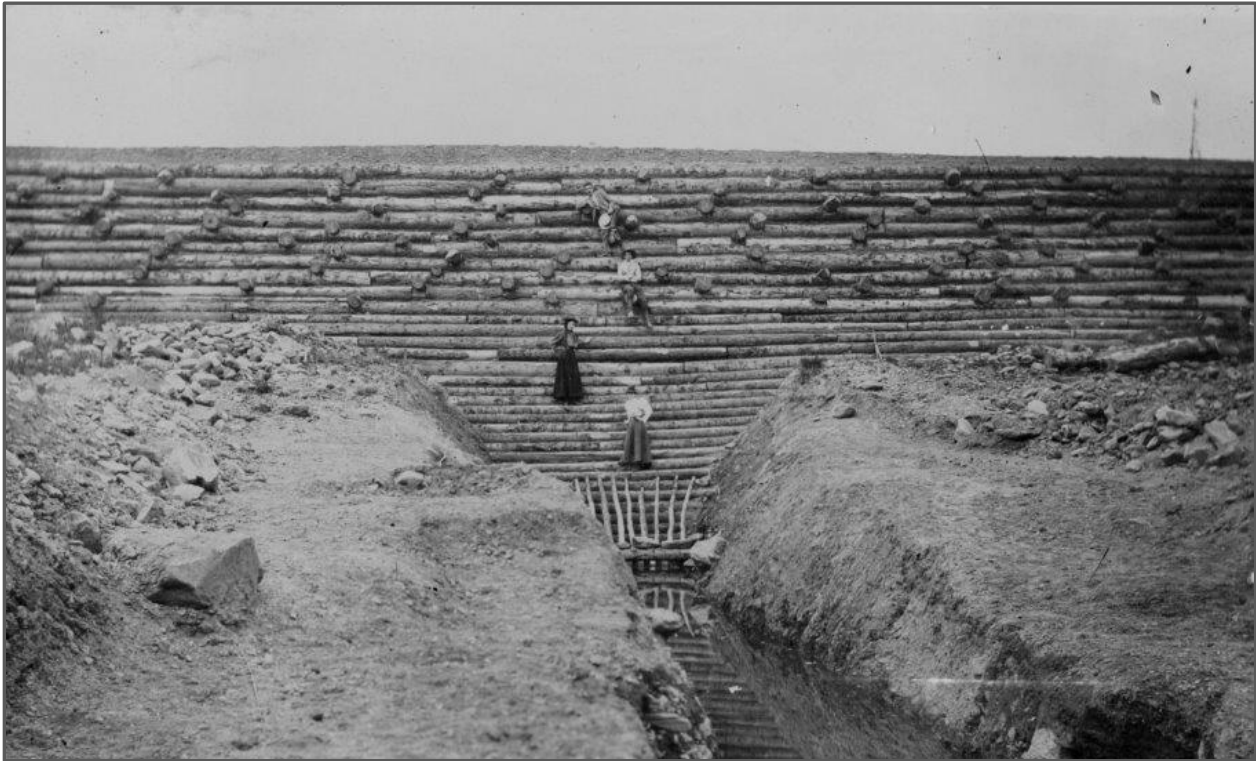
While the dam is now an earthfill structure, historical photographs indicate that it was originally constructed as a log-crib structure (Figure 4-17). BGC was unable to determine why the dam was constructed but presumably it was used to support placer mining in lower reaches of Jack of Clubs Creek. The lake is now a Provincial recreation site.

Figure 4-17 Two men and two women standing on the dam at Groundhog Lake. Barkerville photograph collection, P1055. Unknown date.

According to the Provincial dam database, the Groundhog Lake Dam (File #D820000-0) is an earthfill structure commissioned in 1897 with a dam height of 10 m and a crest length of 100 m. The impounded lake has a surface area of 4.6 ha, and a spillway channel is located on the right (east) abutment. The Provincial database indicates that the dam, which is owned by the BC Ministry of Environment and Parks, has a Low consequence of failure classification rating and a Very Small failure probability rating. The resulting risk level rating is 5 or effectual, which is the lowest risk rating possible.

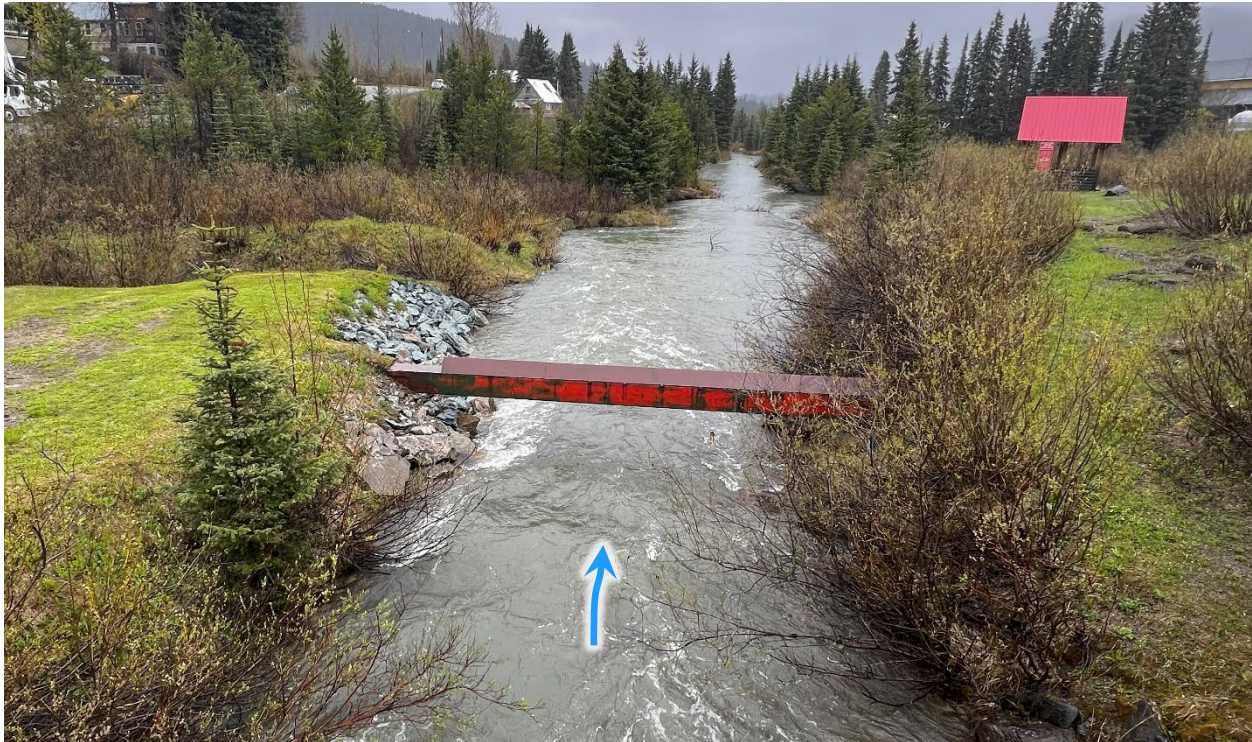
Figure 4-18 From the Jack of Clubs bridge looking downstream (northeast) towards the aerial sewer crossing. BGC photograph of May 28, 2024.

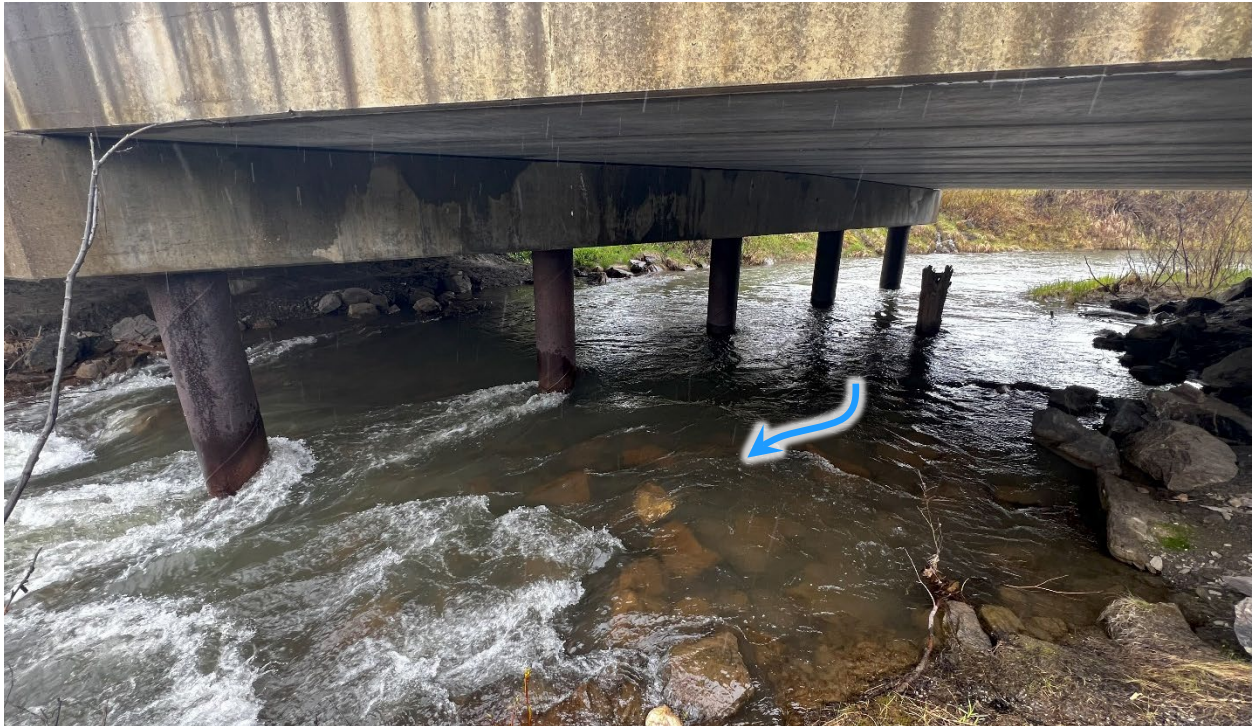
Figure 4-19 From the left (west) bank of Willow River looking upstream (south) towards the piers of the Highway 26 bridge. BGC photograph of May 28, 2024.

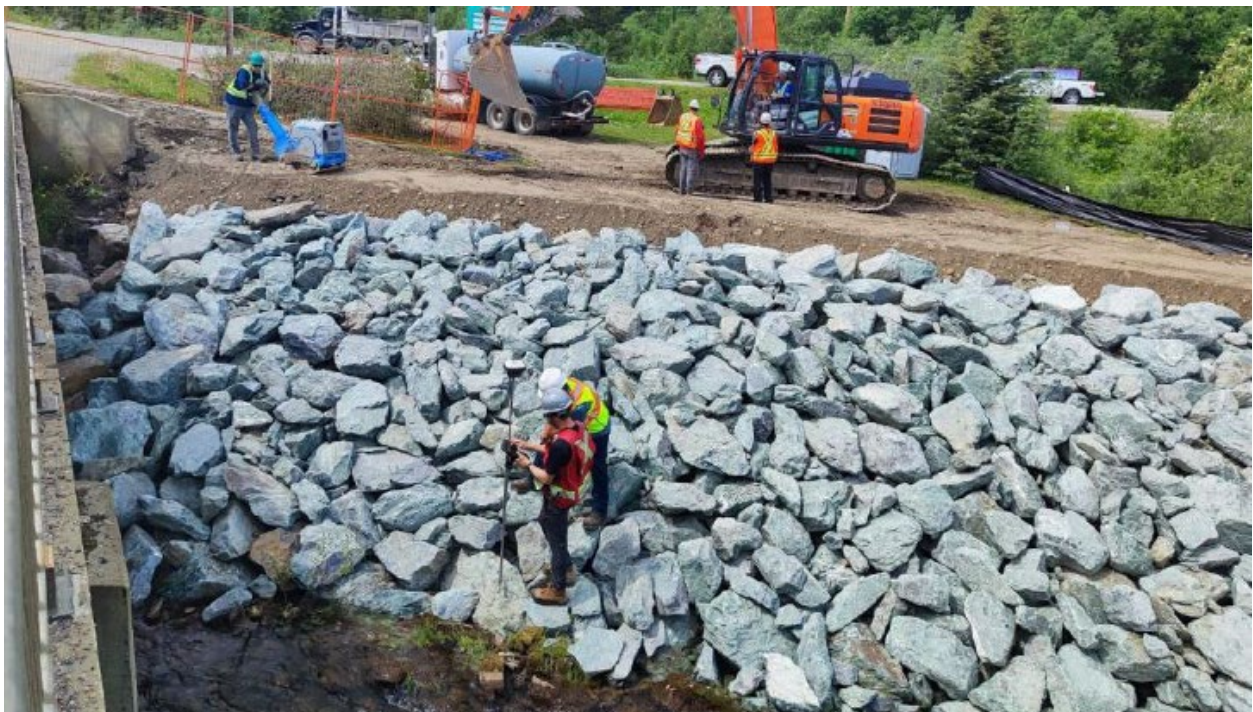
The Highway 26 bridge was constructed in 1994 and crosses Willow River at an oblique angle. The total span length is approximately 24 m with concrete footings on either abutment and five cylindrical steel piers mid span (Figure 4-19). High flows in May 2024 caused concerns of bank erosion impacting the bridge and downstream aerial sewer line. As a result, 250 kg¹⁶ riprap was placed on either bank of the creek for approximately 25 m downstream and 20 m (left bank) to 35 m (right bank) upstream of the bridge in early July 2024 (Figure 4-20). This work was completed on an emergency basis by MoTT and the DoW using a Radloff design (September 25, 2025).

Figure 4-20 Riprap placement on the left (west) bank of Willow River immediately downstream of the Highway 26 bridge. Photo source: Radloff (unknown date).

The infilling of the lake outlet with sediments is also apparent when reviewing the channel profile downstream of Jack of Clubs Lake. The lidar profile in Figure 5-7 shows a relatively flat water surface between the lake outlet and the Highway 26 bridge (El. ~1196.4 m), before dropping abruptly about 1 m over a short distance. This change in gradient is also apparent in Figure 4-20.

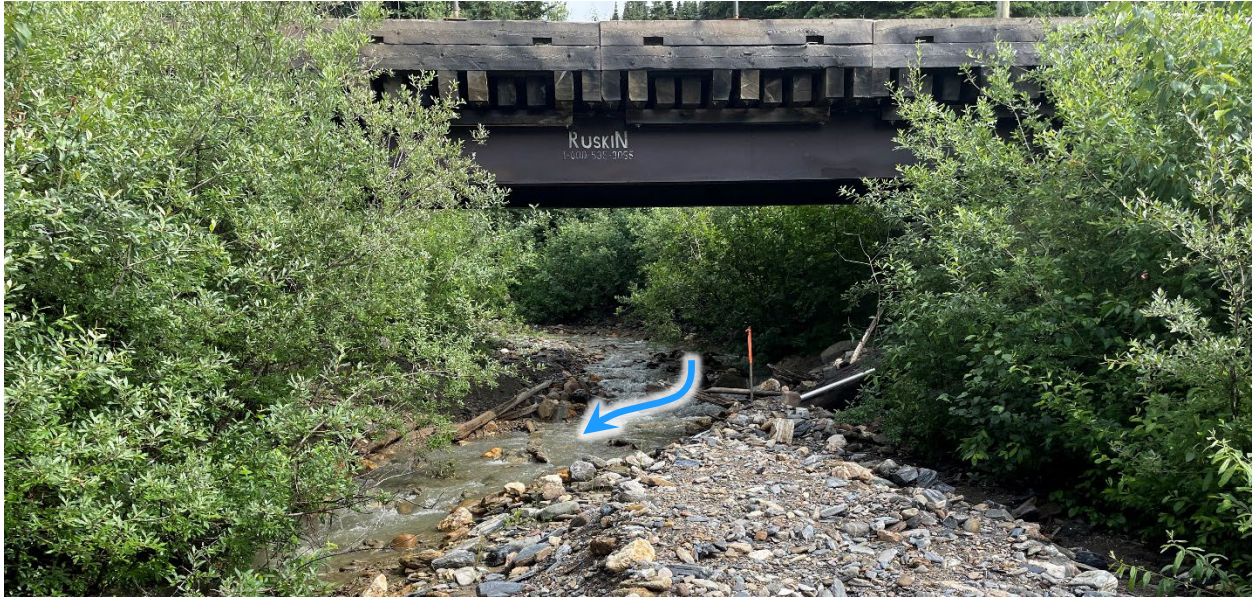
The BGM bridge is located at the fan apex of Lowhee Creek at the end of Ski Hill Road and provides access to the abandoned workings of the Cariboo Gold Quartz Mine. This bridge is approximately 15 m long and is constructed with steel girders on a wooden deck (Figure 4-21).

Figure 4-21 Looking along Lowhee Creek upstream (east) towards the BGM bridge. Photo source: Radloff (unknown date).

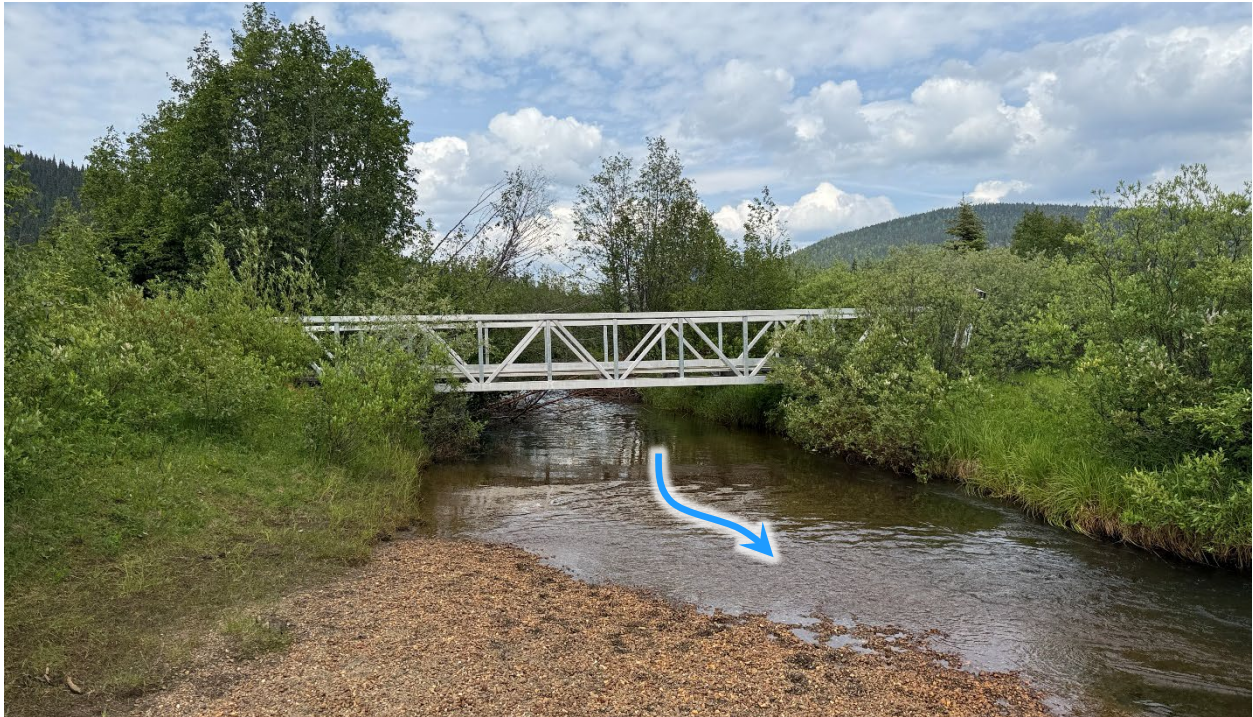
There are also two pedestrian footbridges to the north of Wells. The upstream aluminum footbridge is on the Creekside trail system and crosses Williams Creek about 500 m northeast of town (Figure 4-22). The downstream footbridge is on Sugar Loaf trail, which starts at the north end of the townsite and crosses the Willow River about 400 m north. This bridge is 12 m long and constructed with 0.95 m thick steel girders that support a wooden deck (Figure 4-23). The bridge accesses trails on the north side of the river as well as a frisbee golf course.

Figure 4-22 Upstream view of pedestrian bridge crossing of Williams Creek. BGC photograph of June 24, 2025.

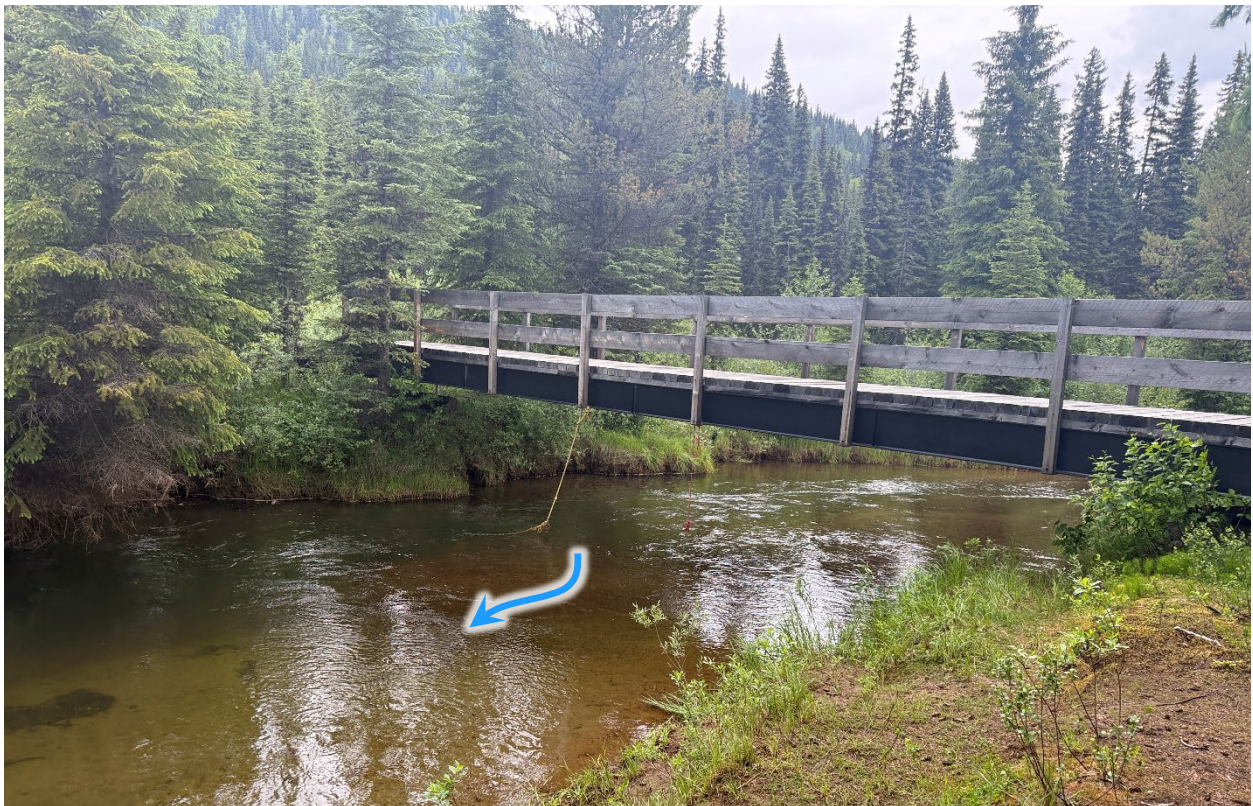
Figure 4-23 Upstream view of pedestrian bridge crossing of Willow River. BGC photograph of June 24, 2025.

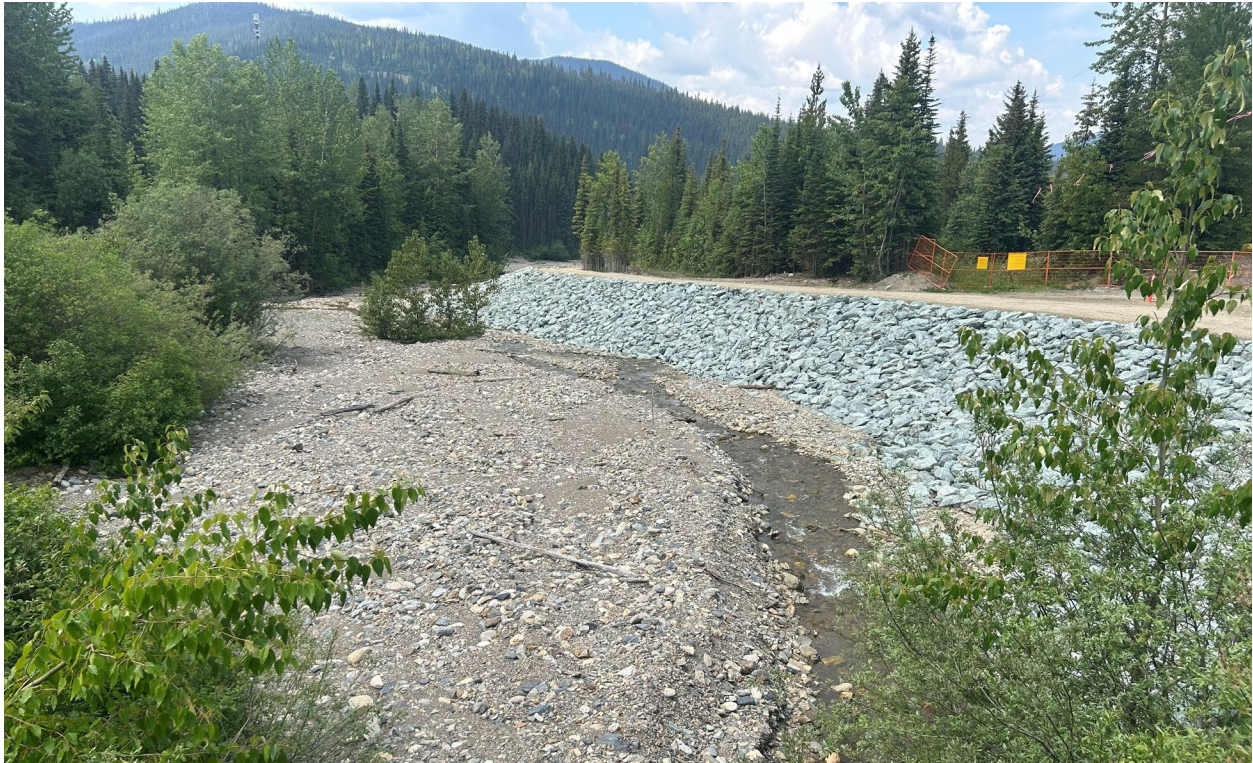
Figure 4-25 Downstream view of Lowhee Creek from the BGM bridge. The Phase 1 and 2a dike is visible on the right bank. BGC photograph of June 22, 2025.
