District of Wells Regional Flood Hazard Assessment

Project 2546-006

Document 2546006-001-RP-RevA

Regional Flood Hazard Assessment – DRAFT

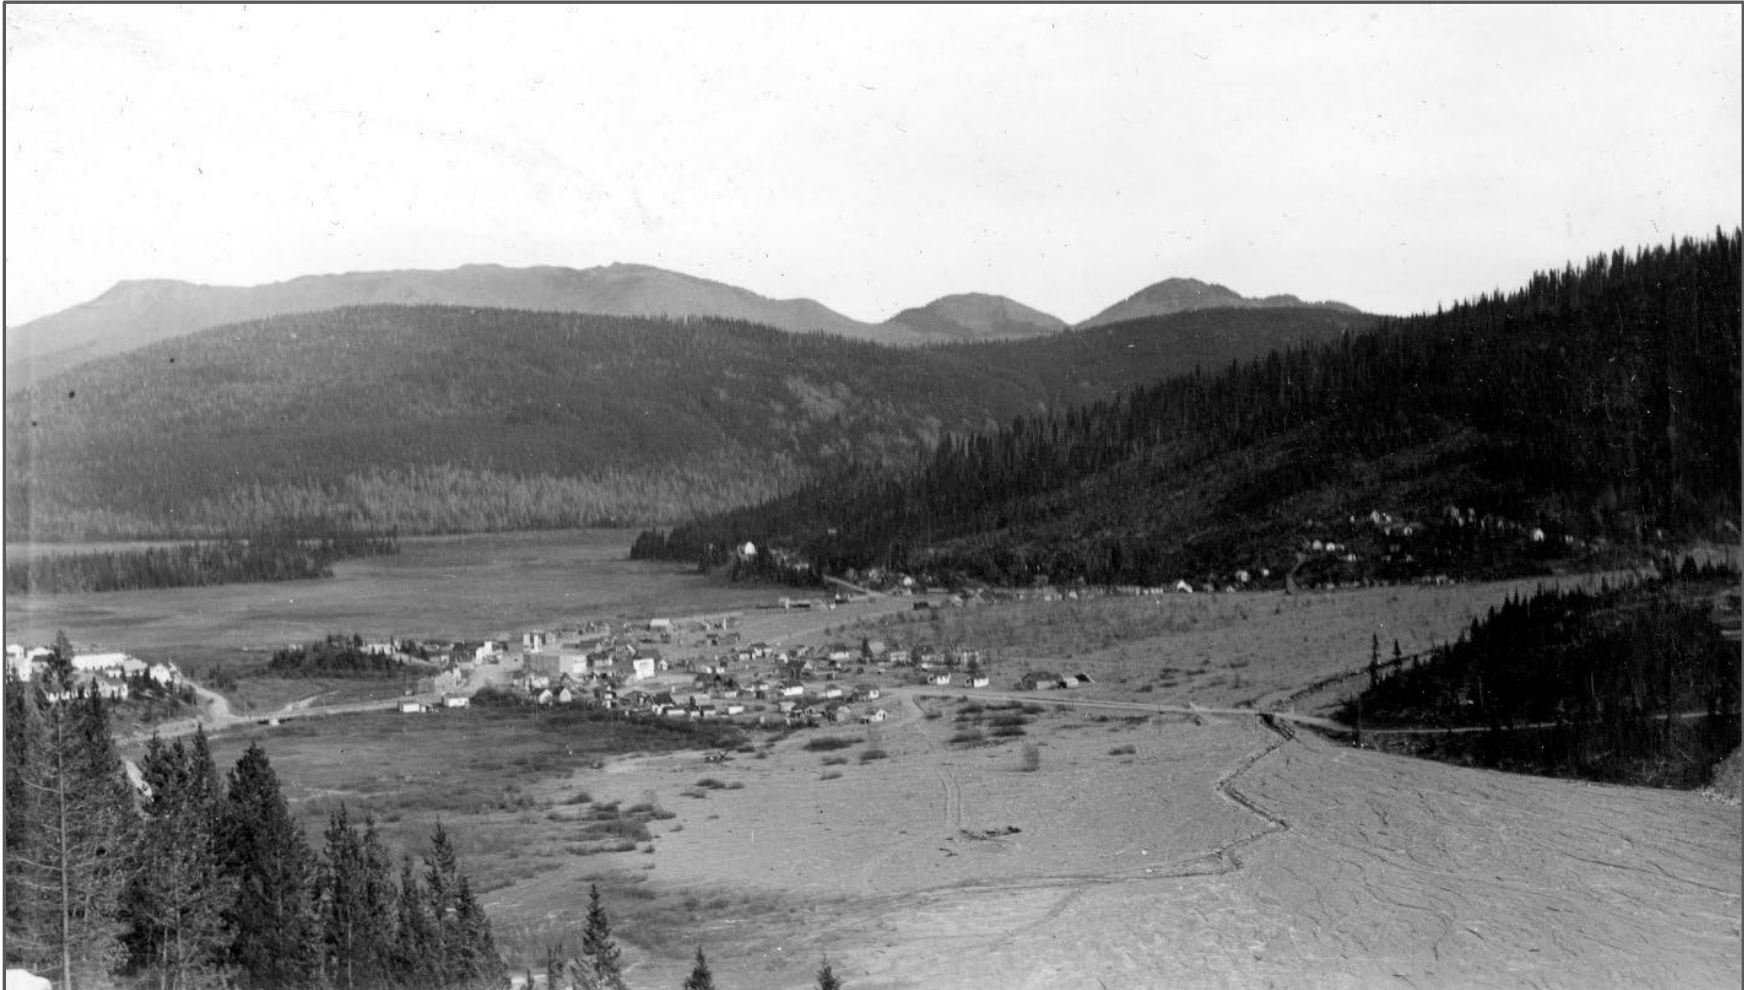
A 1940 photograph of the Lowhee Creek alluvial fan clearly shows the extent of the placer outwash deposits (Figure 5-3).

Figure 5-3 1940 photograph looking toward south Wells and Lowhee Creek alluvial fan. Source: City of Vancouver Archives Items: CVA-289-005.602 – South Wells, B.C.

While most of the hydraulically mined sediment appears to have deposited to the east of the current Lowhee Creek channel, some of this sediment appears to have partially infilled the northeastern end of Jack of Clubs Lake also. The earliest air photographs of the area date to 1952, which post-dates the deposition of flotation tailings and a majority of the placer outwash (Figure 3-3). However, the approximate pre-development downstream extent of Jack of Clubs Lake can be inferred from several sources.

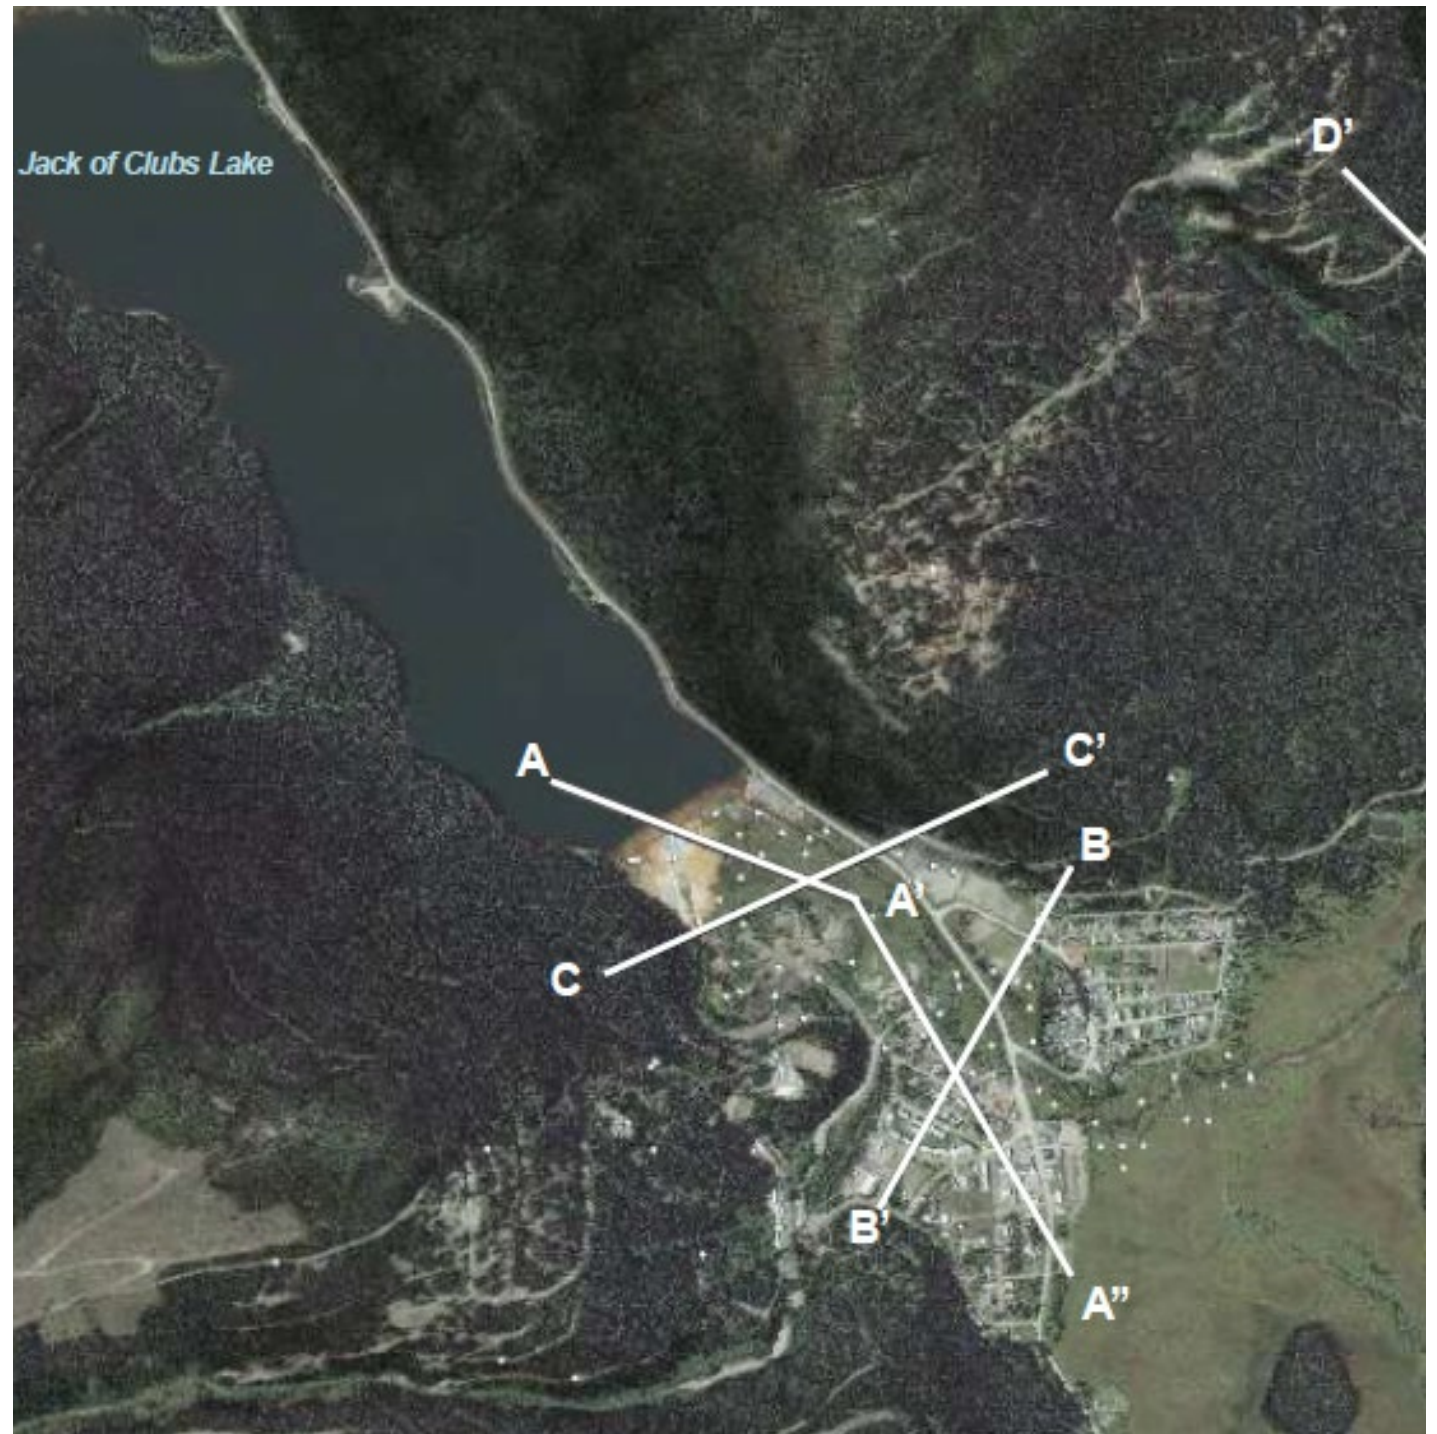
Figure 5-4 Geologic cross-sections through the Lowhee Creek fan (from Golder, June 24, 2021).

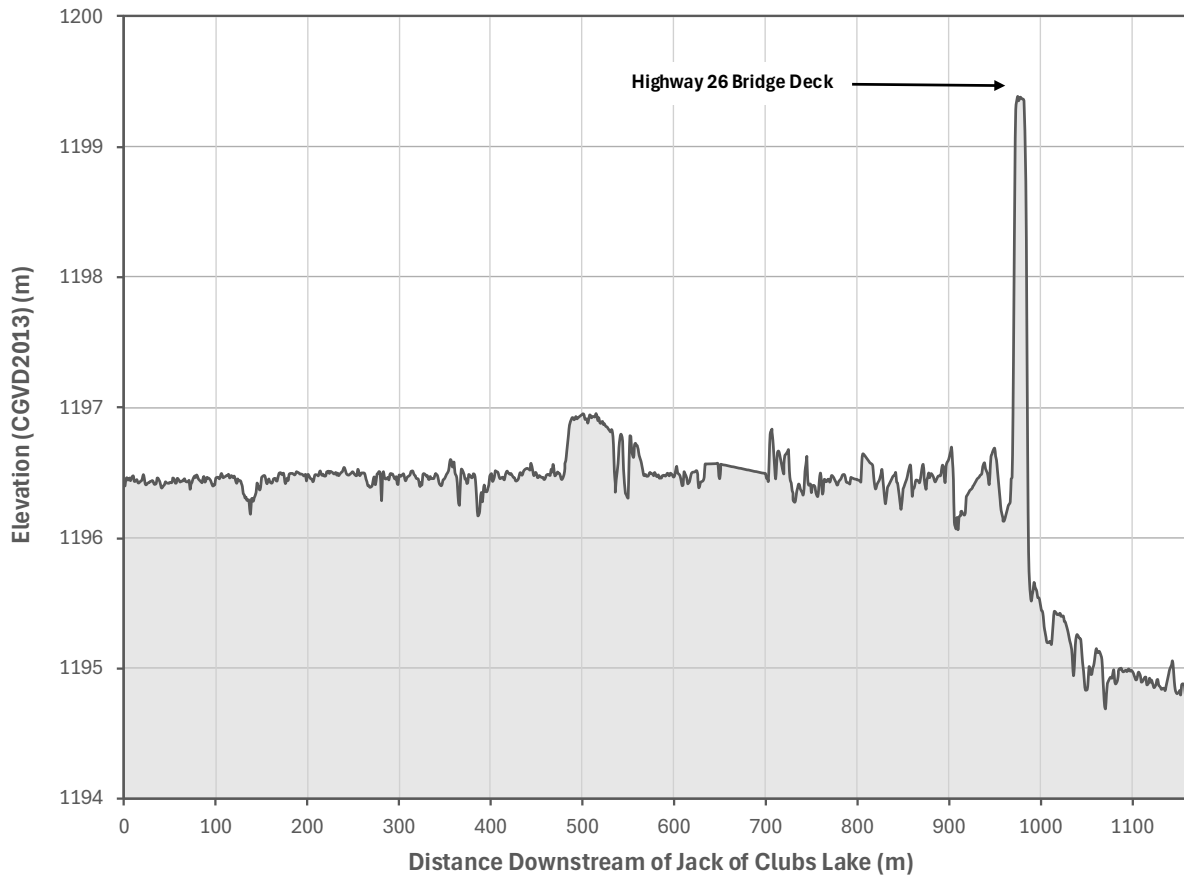
Figure 5-7 Willow River channel profile downstream of Jack of Clubs Lake using 2021 lidar data.

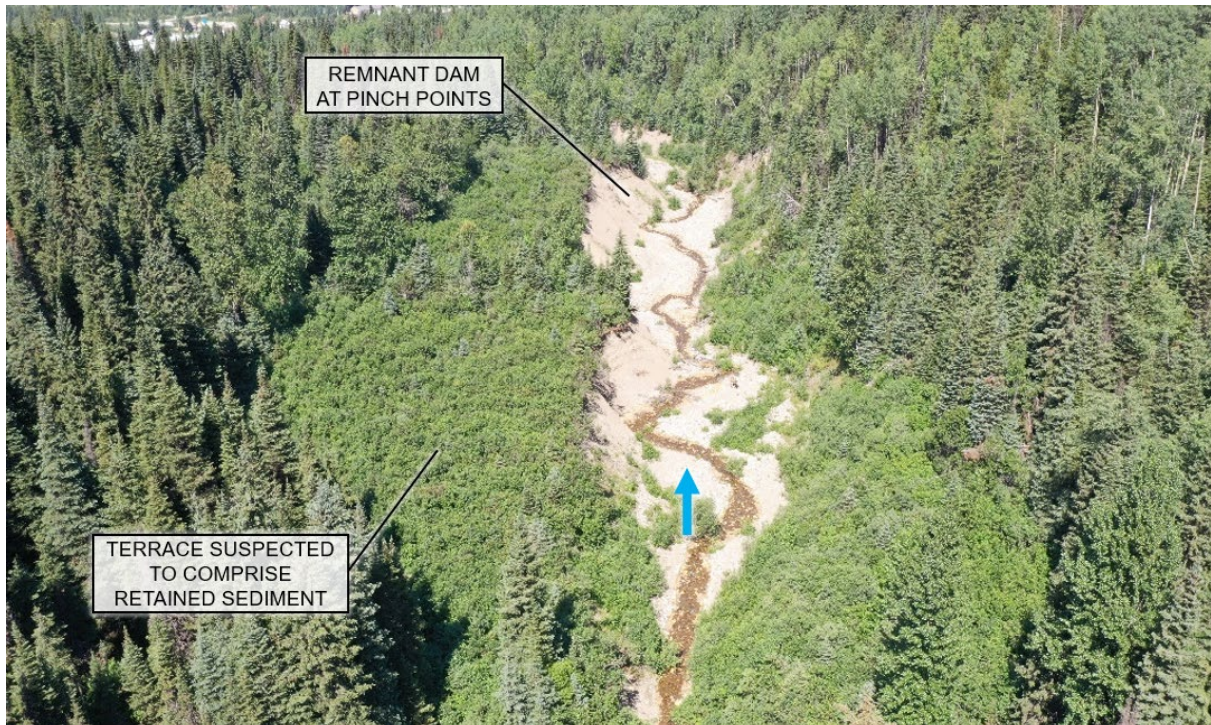
Figure 5-8 Looking downstream at the Lower Watershed reach with exposed terrace walls. Photo source: BGC, August 7, 2024.

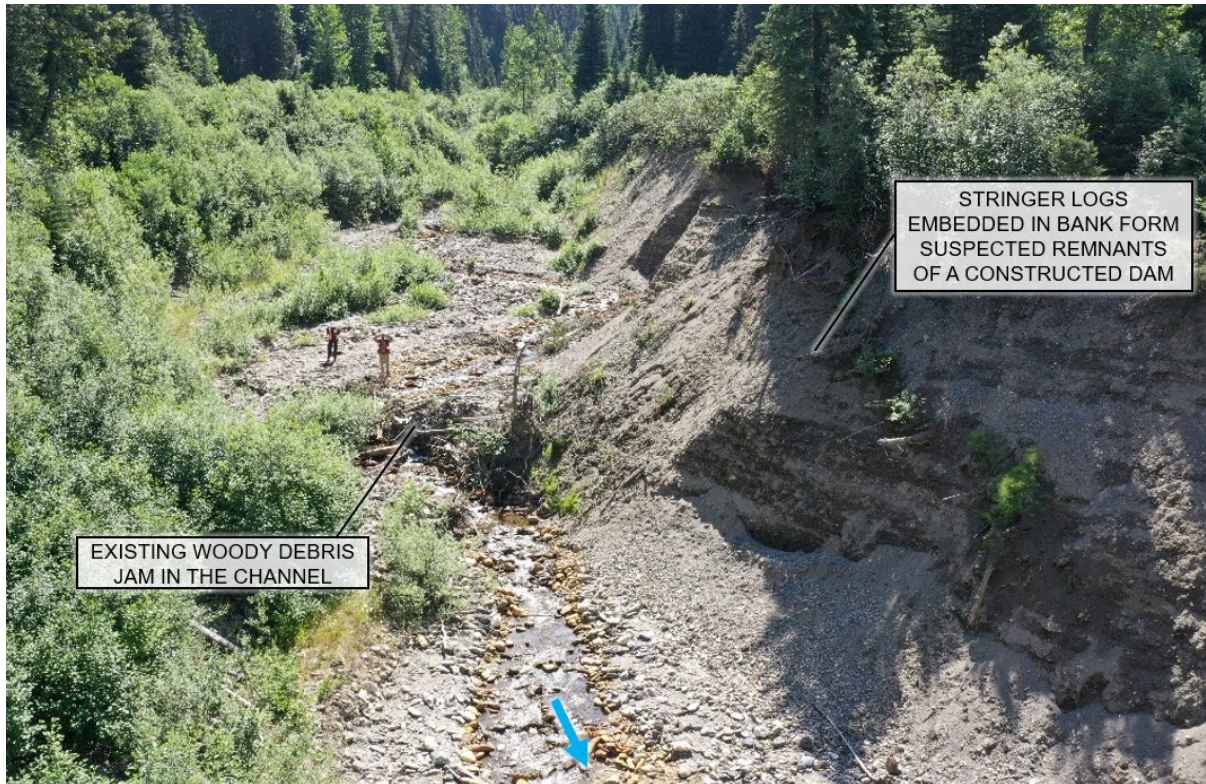
Figure 5-9 Looking upstream at a remnant dam and existing woody debris jam. Photo source: BGC, August 7, 2024.

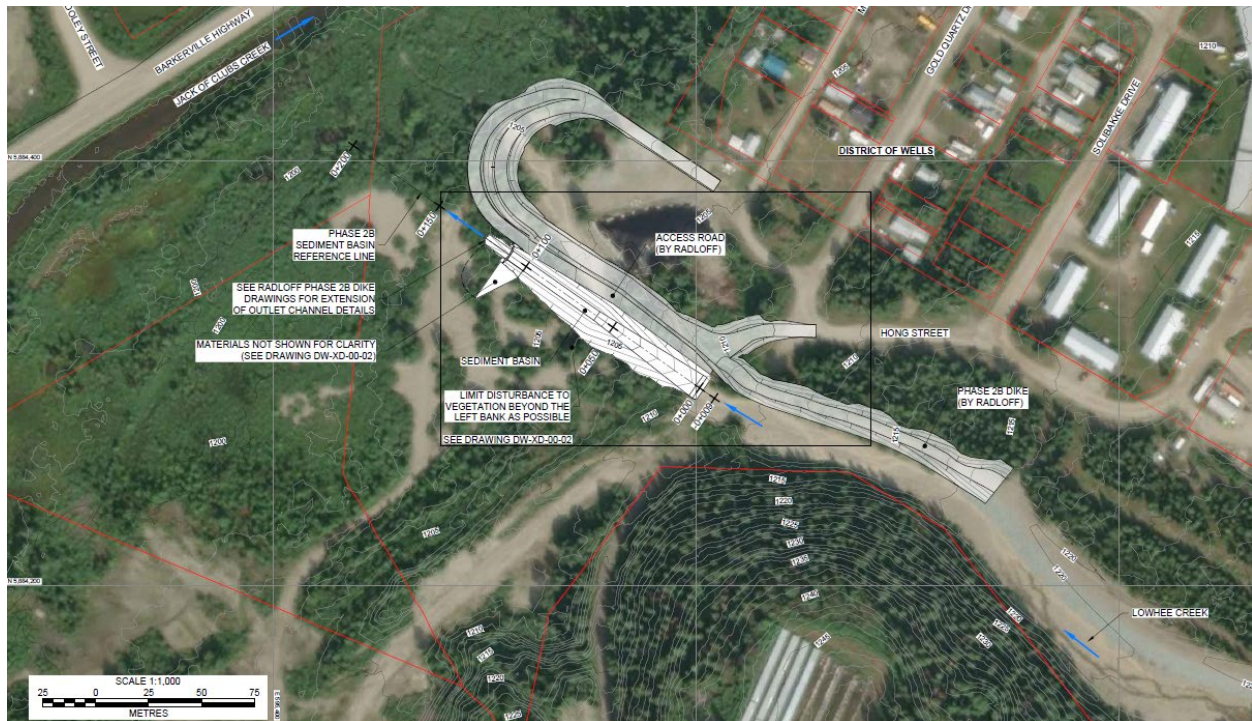
Figure 5-10 General arrangement of the Lowhee Creek Phase 2c sediment basin (BGC, September 19, 2025).

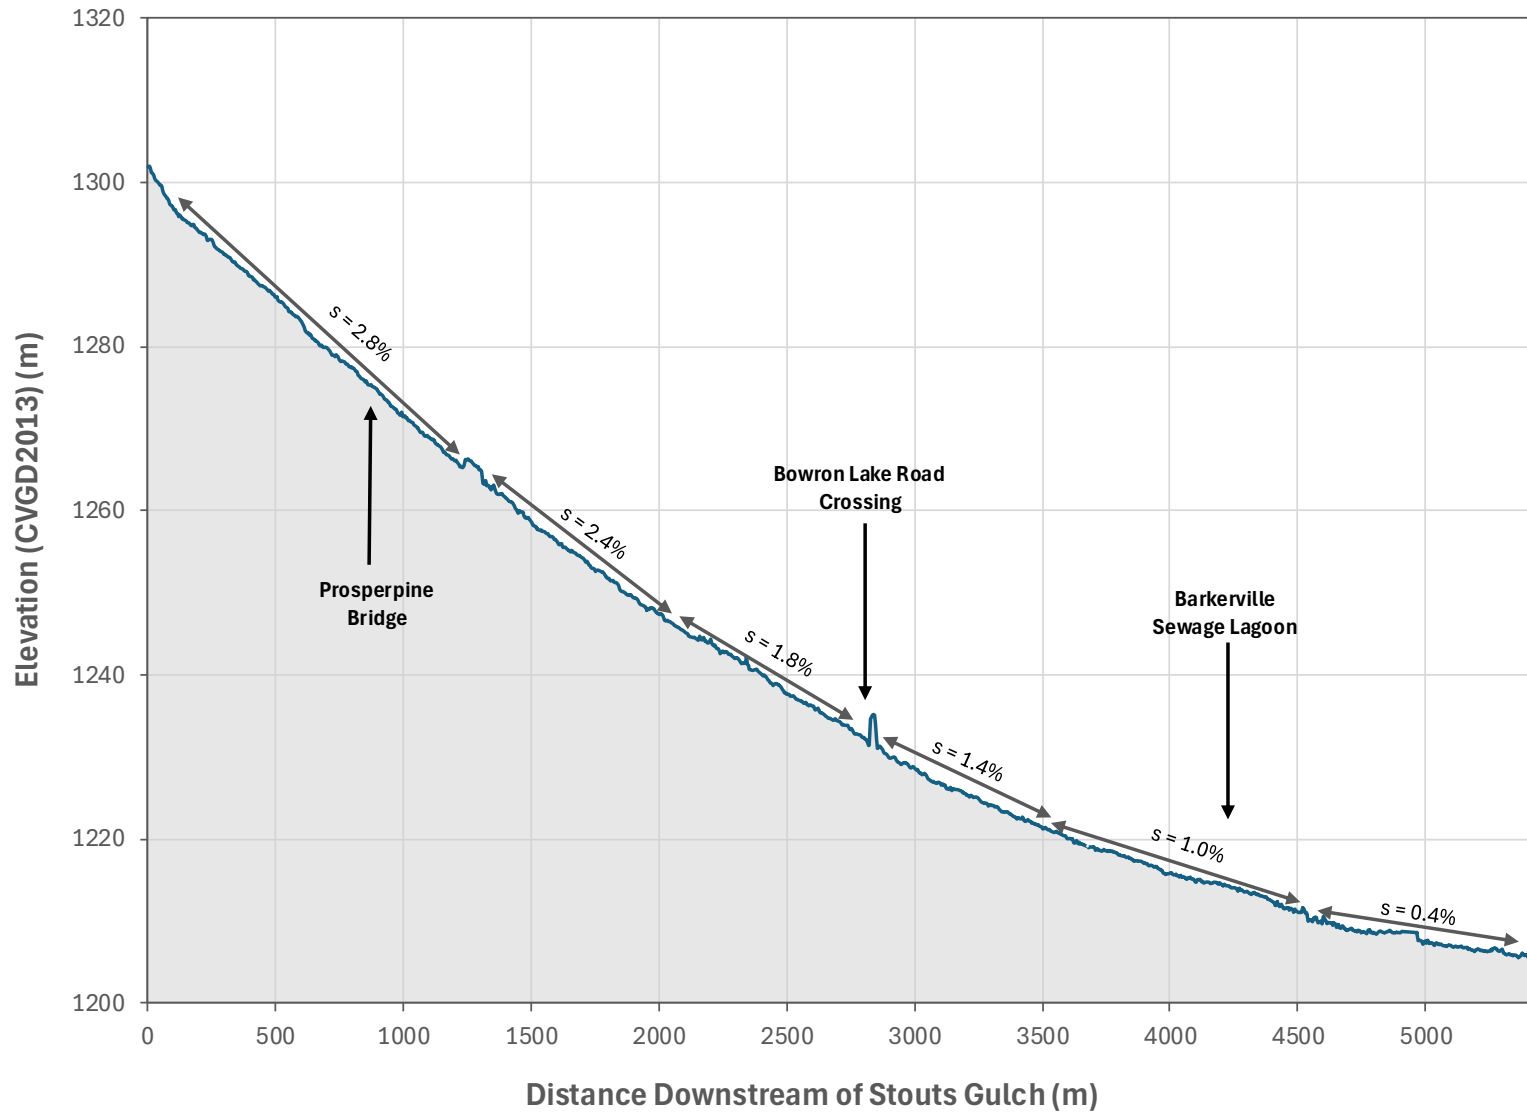
Figure 5-11 Williams Creek channel profile downstream of Stouts Gulch using 2021 lidar data.

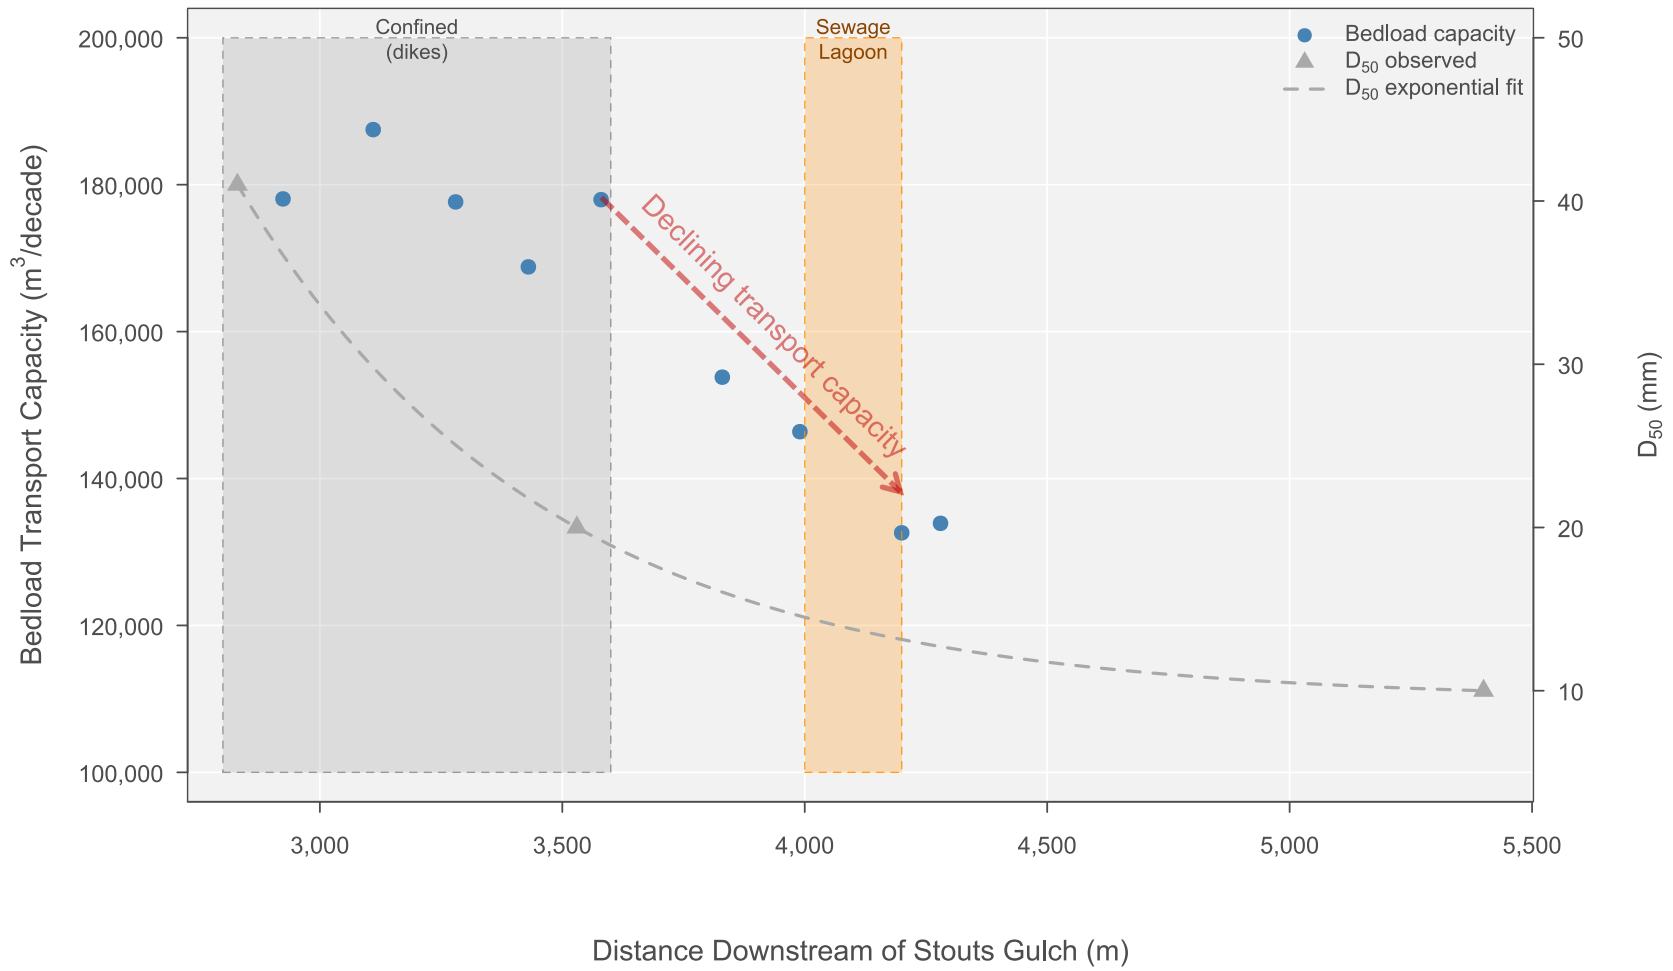
Figure 5-12 Williams Creek bed texture and transport capacity downstream of Bowron Lake Road. The section of stream confined by dikes on both sides of the creek is indicated in grey. The location of the Barkerville wastewater lagoons is indicated in orange.
